# Millwater Subdivision

Arrans Hill Precinct - Stage 5

Prepared for  
WFH Properties Ltd

Title: Millwater Subdivision					
Date	Version	Description	Prepared by:	Reviewed by:	Authorised by:
December 2019	1	Geotechnical Completion Report	JASM	APS	APS

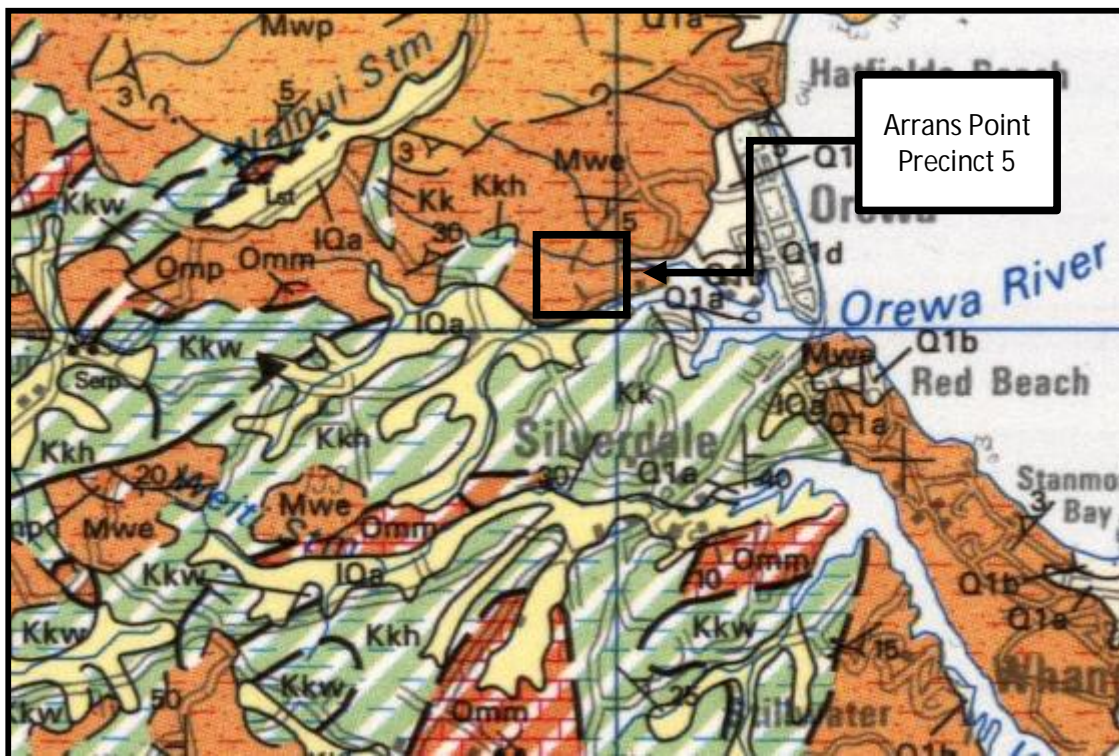
Figure 1.1: Local Geology (from Edbrooke)

Published geological mapping and information indicates the Arrans Hill Precinct 5 area is underlain by East Coast Bays Formation (ECBF) materials (Figure 1.1). In addition to the ECBF materials, our investigations identified the presence of alluvial and colluvial materials on site along the stream margins (Ref 4 and 5).

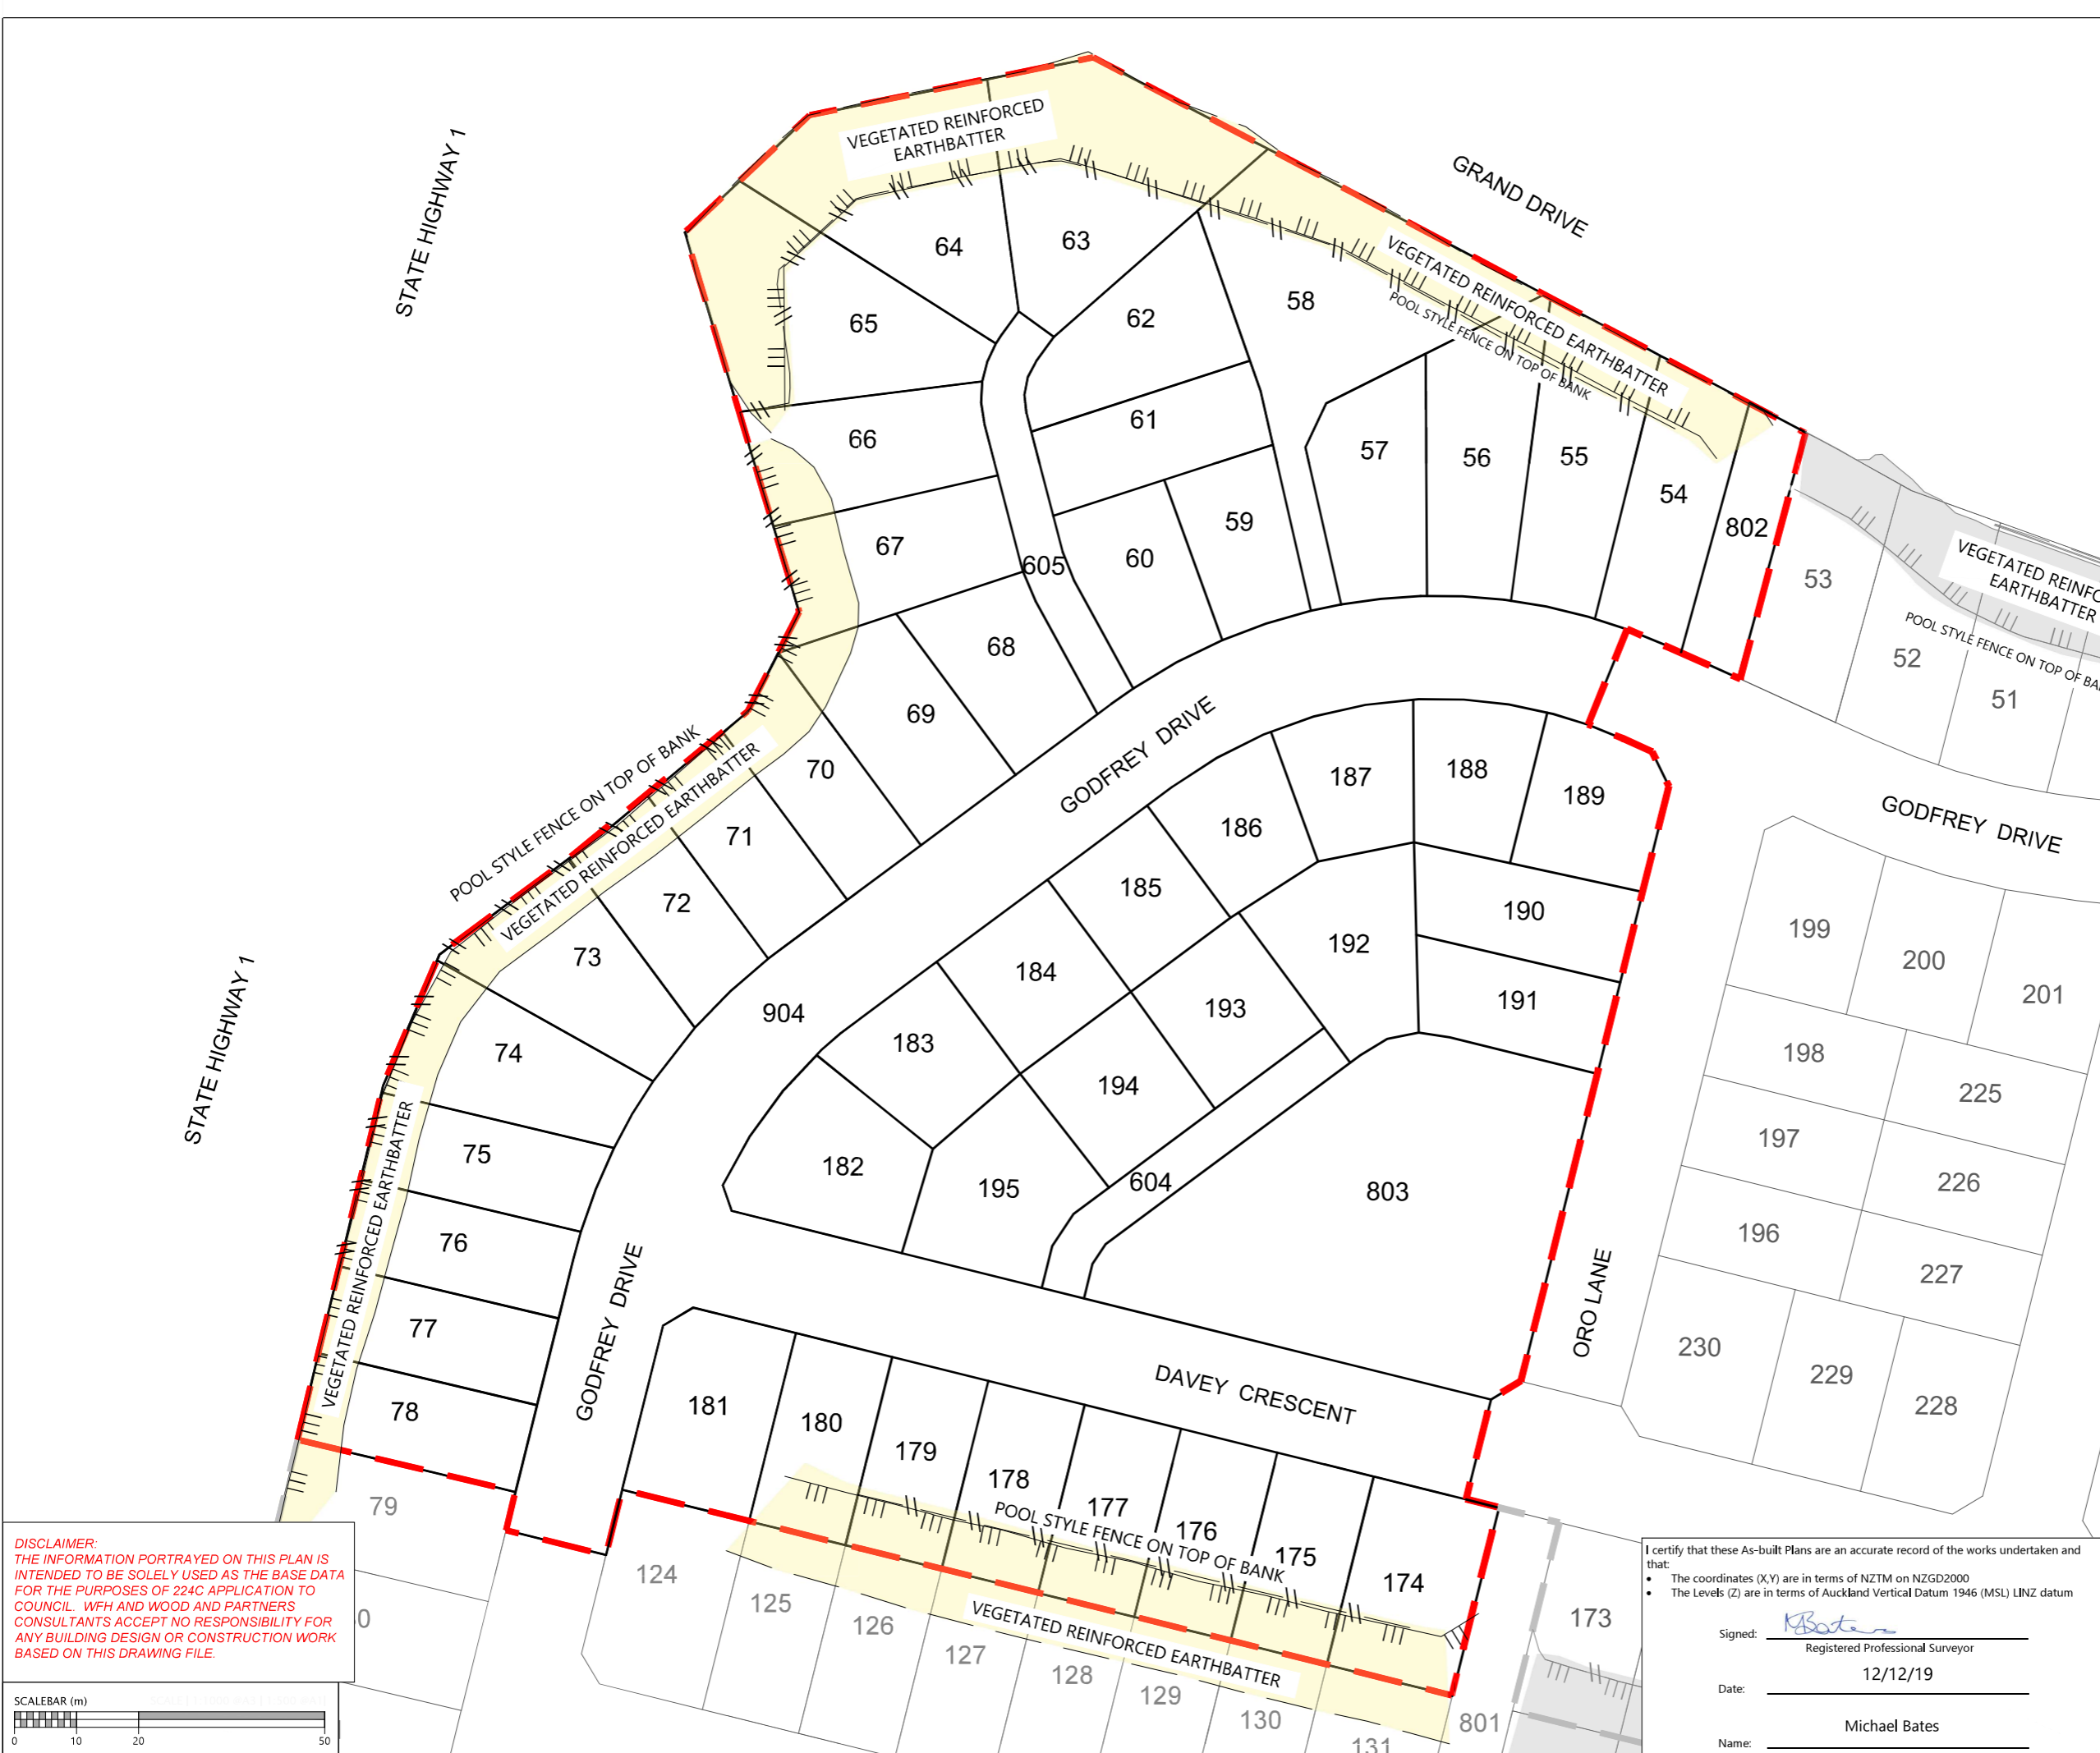
STATUS	ASBUILT	REV
SCALE	1:1000 @ A3	2
COUNCIL	AUCKLAND COUNCIL	
DWG NO	37505-05-140-AB

**REINFORCED EARTH BATTER,  
SLOPE STABILISATION &  
RETAINING WALL PLAN**

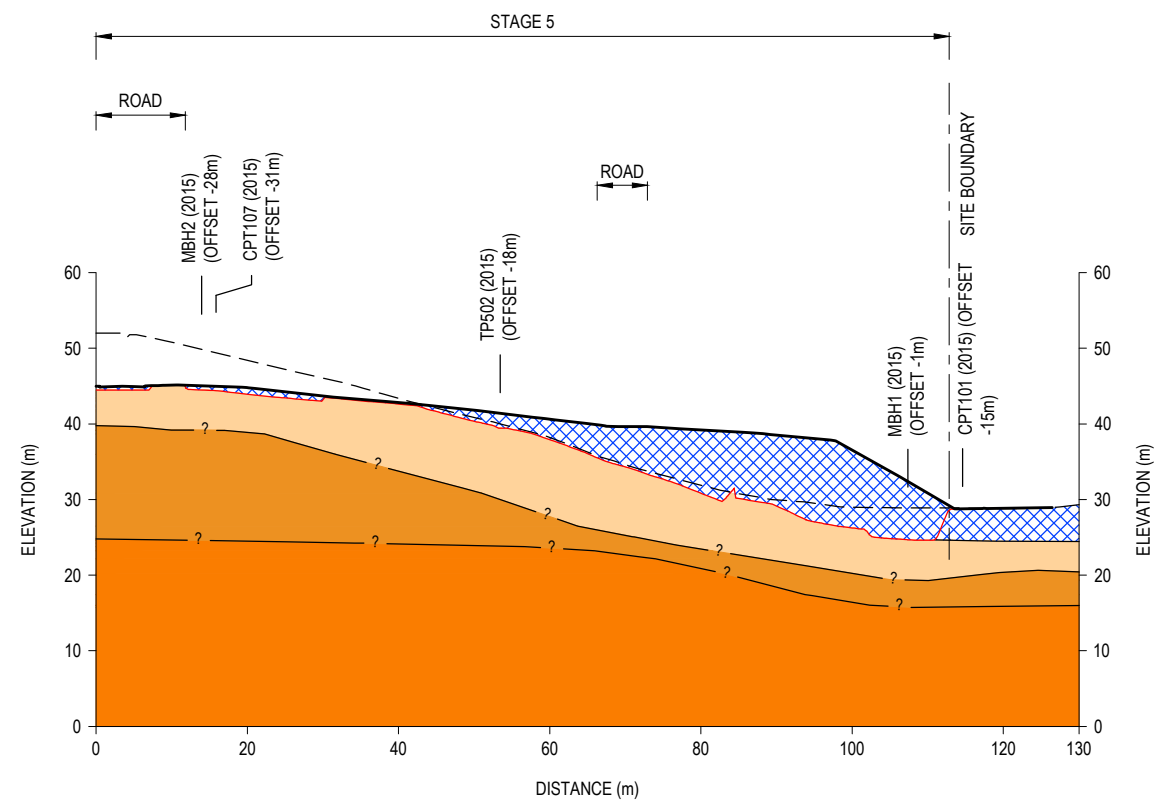
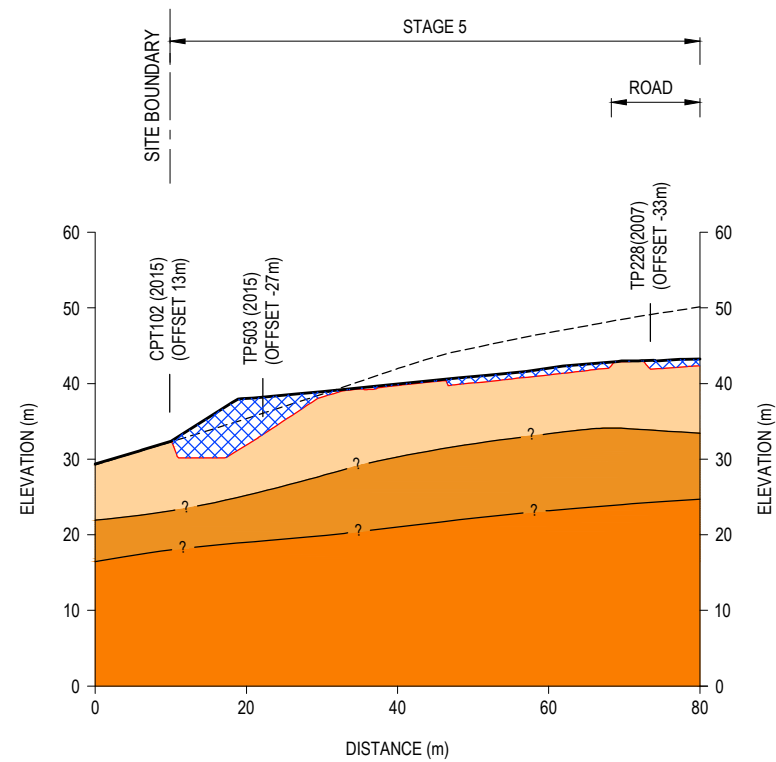
CLIENT	WFH PROPERTIES LTD
PROJECT	MILLWATER - ARRANS HILL
TITLE	PRECINCT 5 STAGE 5 GEOLOGICAL CROSS SECTIONS 1 & 2
SCALE (A3)	1:1000
DWG No.	21854.0031-AHP5S5-103
REV	1

SECTION 1  
SCALE 1: 1000

SECTION 2  
SCALE 1: 1000

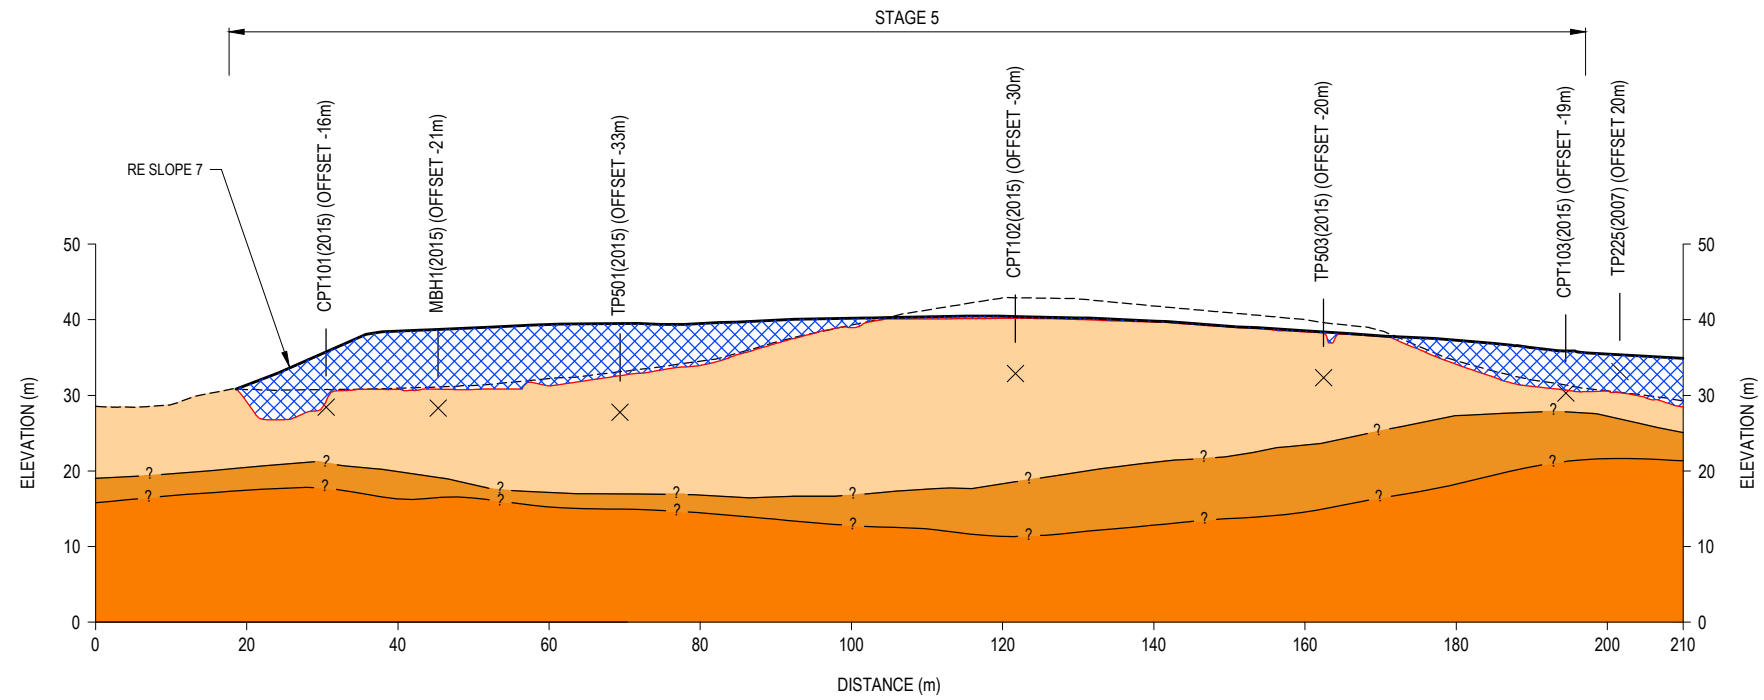
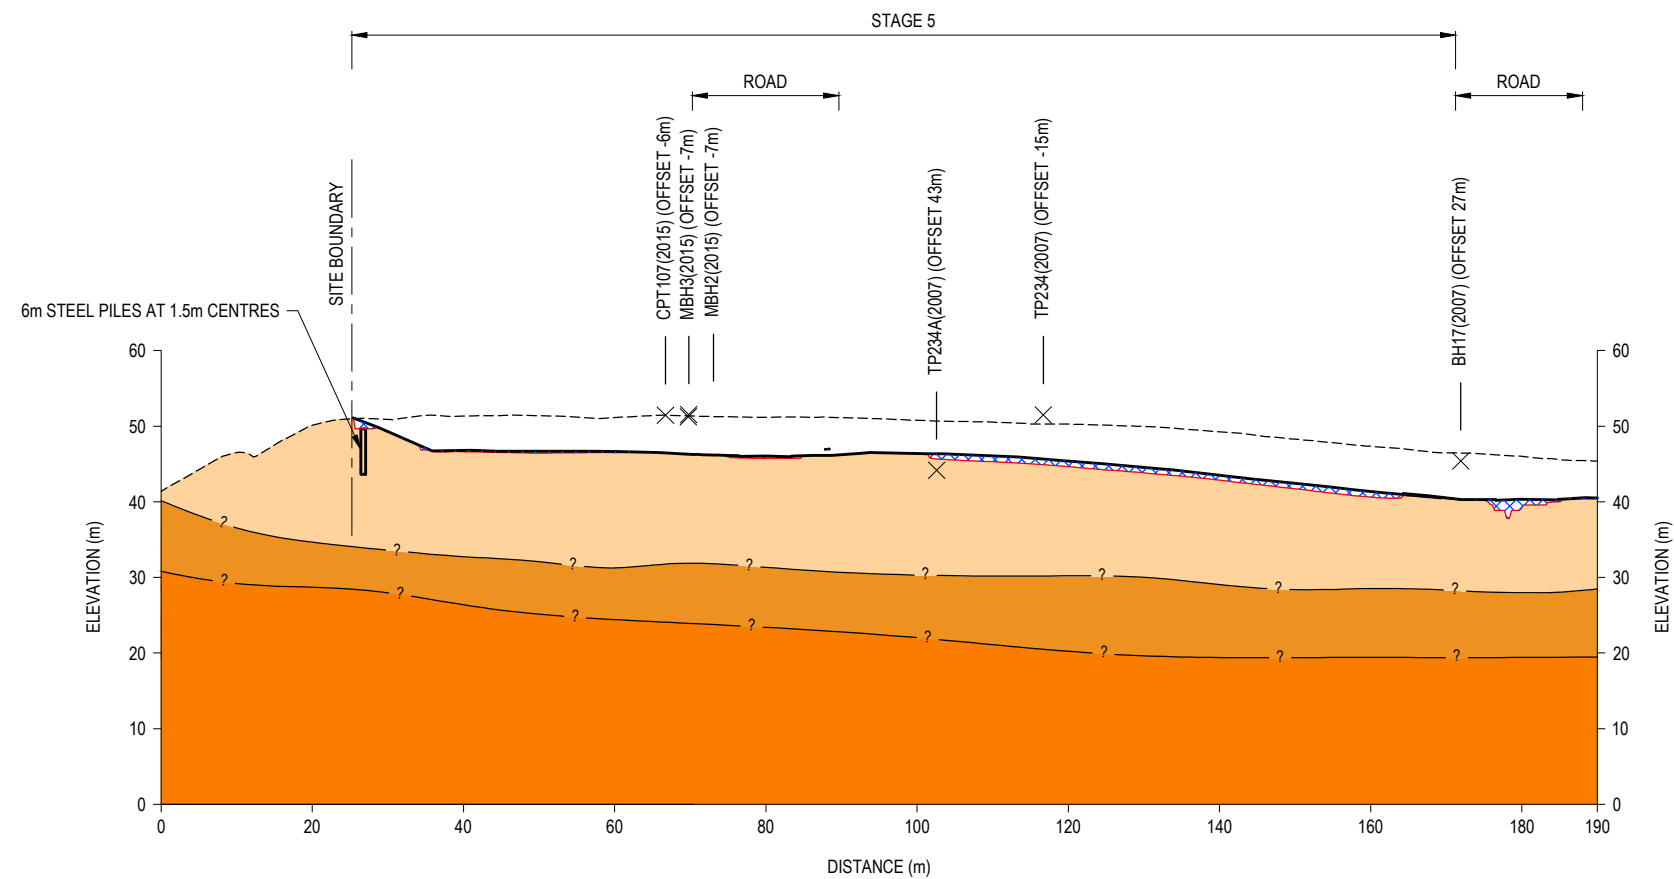
CLIENT	WFH PROPERTIES LTD
PROJECT	MILLWATER - ARRANS HILL
TITLE	PRECINCT 5 STAGE 5 GEOLOGICAL CROSS SECTIONS 3 & 4
SCALE (A3)	1:1000
DWG No.	21854.0031-AHP5S5-104
REV	1

SECTION 3  
SCALE 1: 1000

SECTION 4  
SCALE 1: 1000

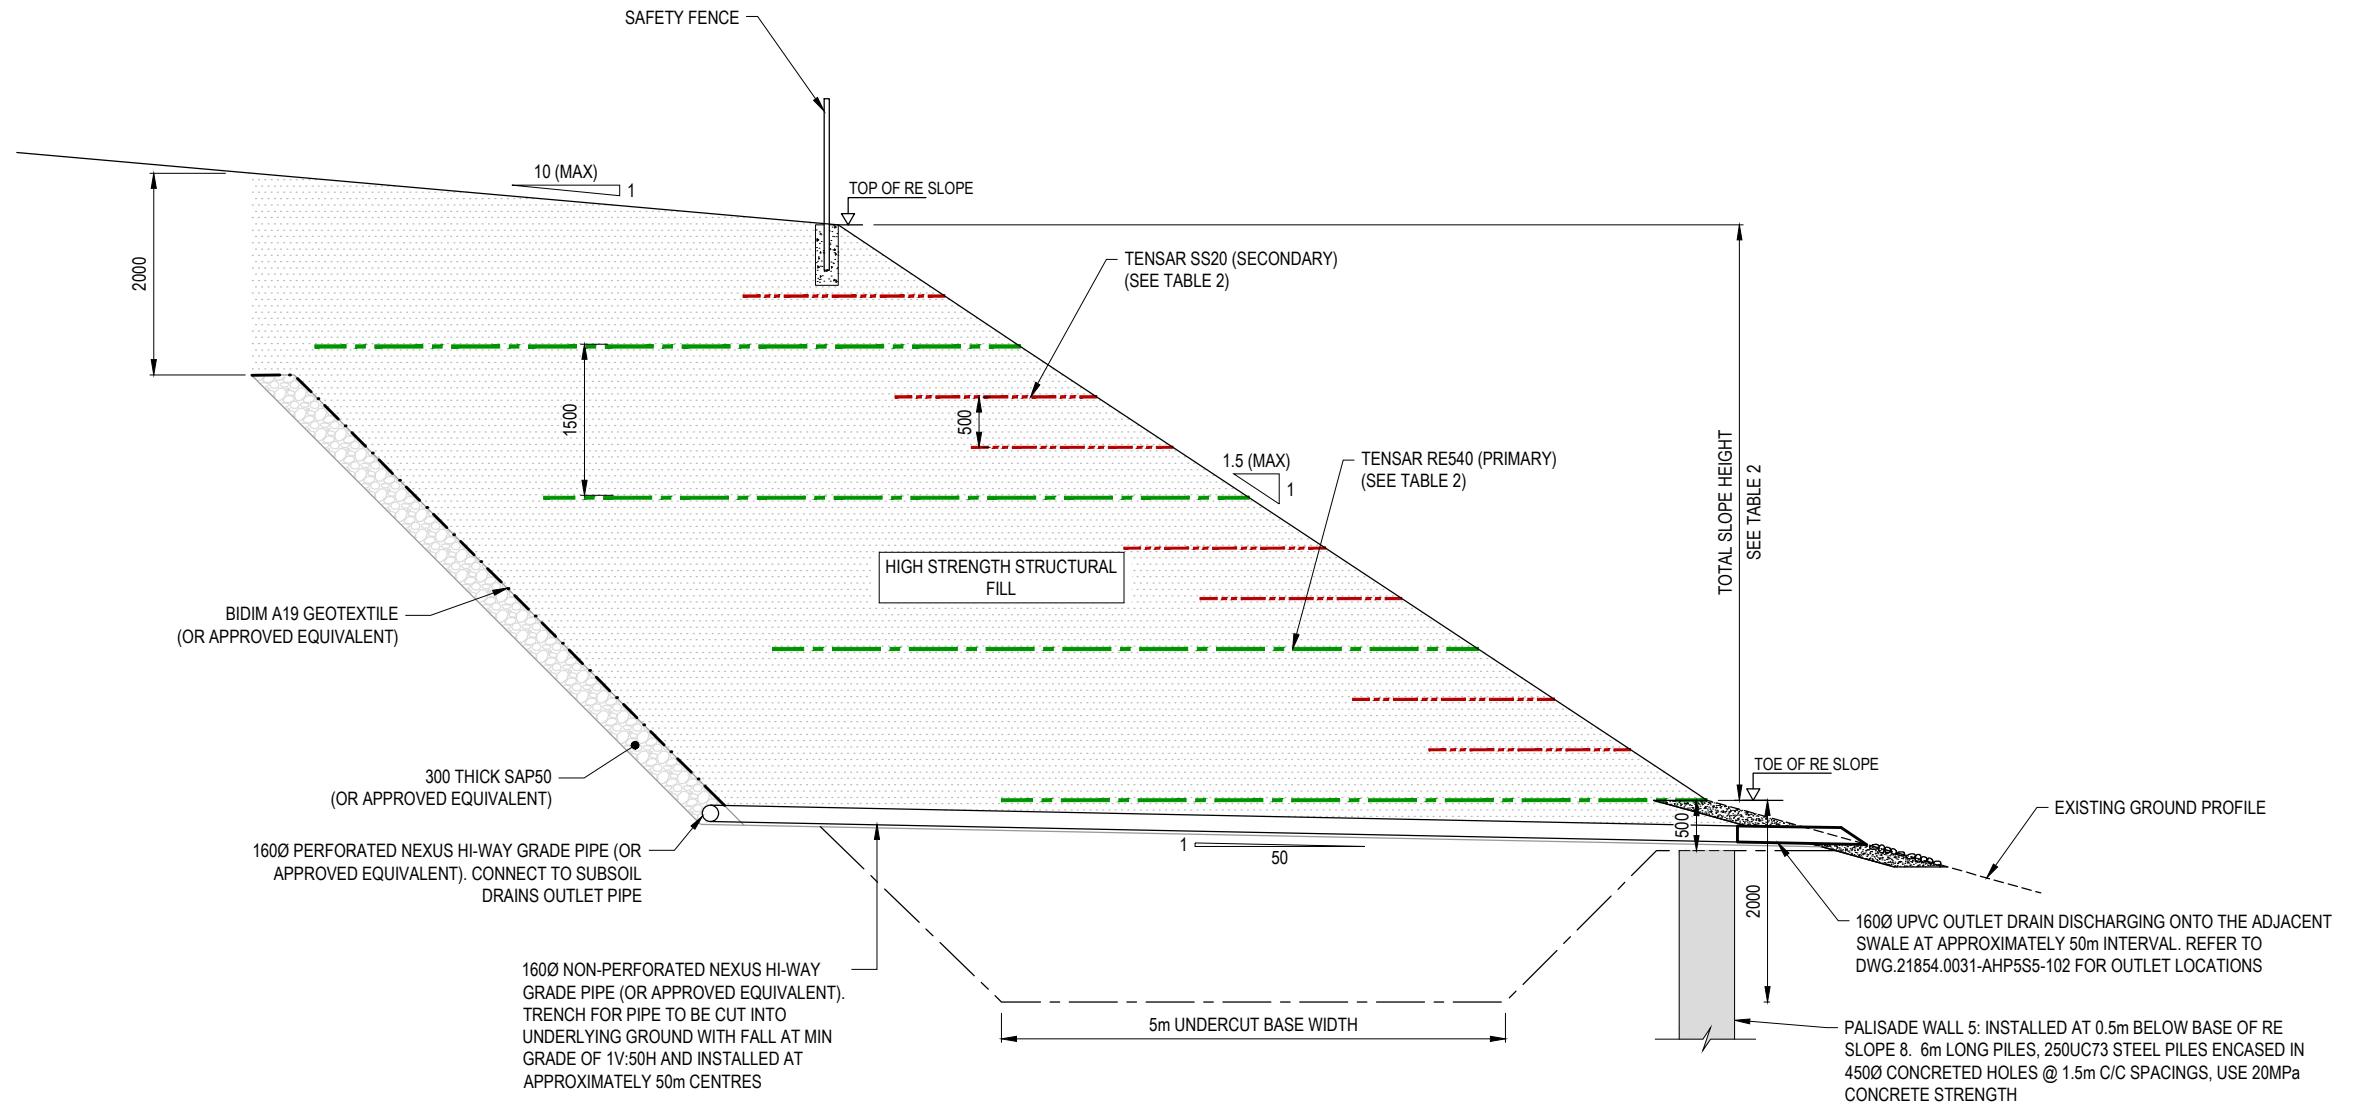
SECTION 7 RE SLOPE 8 WITH PALISADE WALL 5  
SCALE 1:75

LEGEND	
	BIDIM A19 GEOTEXTILE
	TENSAR SS20 (SECONDARY)
	TENSAR RE540 (PRIMARY)
	HIGH STRENGTH STRUCTURAL FILL
	SAP50 SCORIA

The foundations of Reinforced Earth Slope 8 are composed of engineered fill material from undercut and part of Palisade Wall 5, as outlined in Sections 3.2 and 3.3, and presented on T+T Drawing 21854.0031-111 to 112 in Appendix B. The foundations of Reinforced Earth Slope 4 are composed of engineered fill material, presented on T+T Drawing 21854.0031-110 in Appendix B.

As noted in Section 3.1, a drainage blanket was installed at the rear of the reinforced block of soil and comprises a minimum of 300mm thickness of SAP50 scoria, covered in Bidim A19 geotextile filtercloth and a cap of engineered cohesive fill 2m in thickness. A 160mm diameter perforated Hiway grade Nexus drain pipe was installed at the base of the drainage blanket and provides regular discharge outlets for any groundwater captured in the drainage blanket.

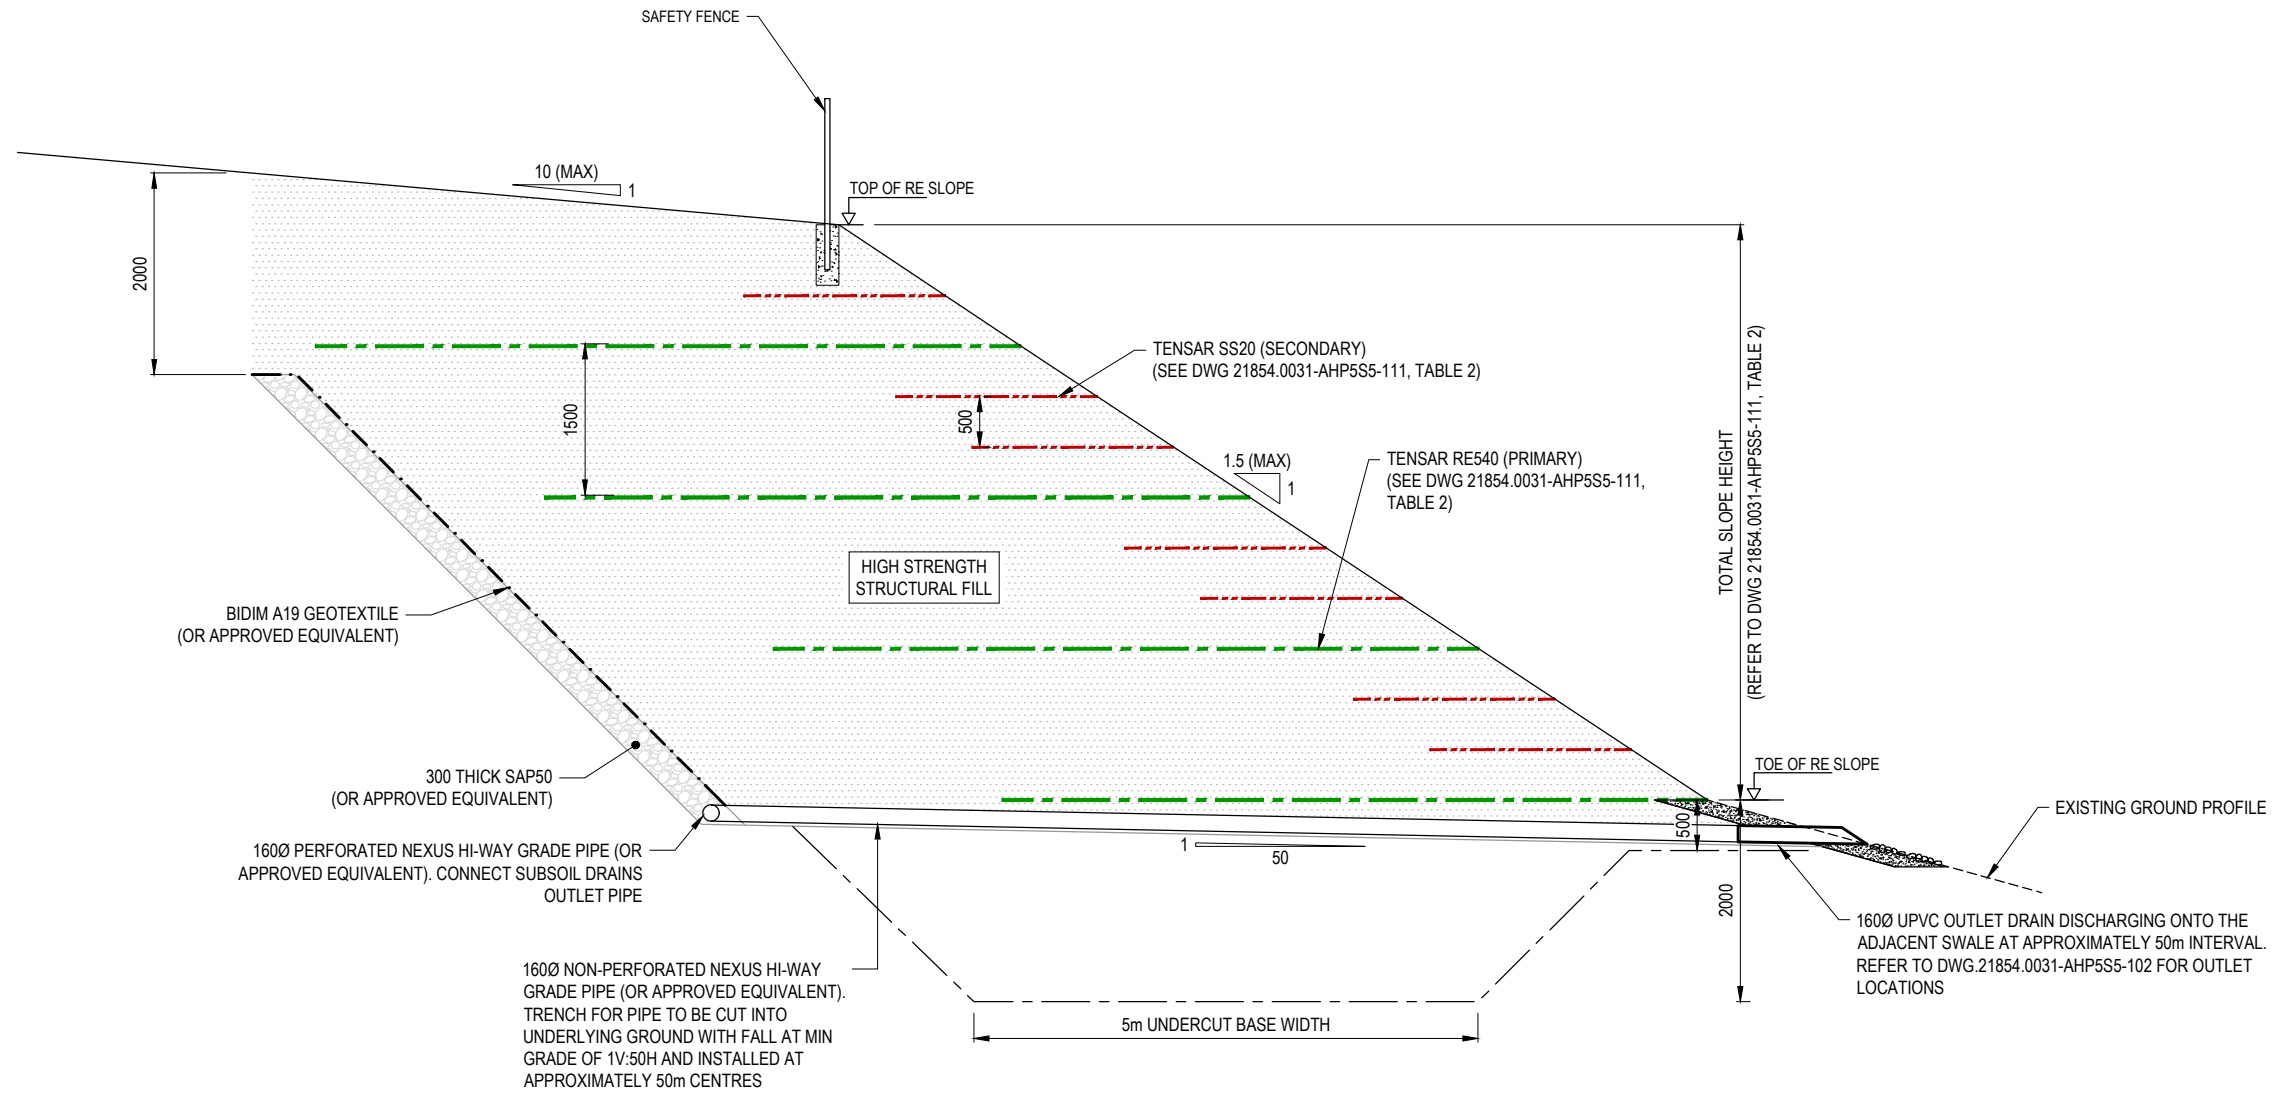
SECTION 8 RE SLOPE 8  
 SCALE 1:75

LEGEND	
	BIDIM A19 GEOTEXTILE
	TENSAR SS20 (SECONDARY)
	TENSAR RE540 (PRIMARY)
	HIGH STRENGTH STRUCTURAL FILL
	SAP50 SCORIA

At the toe of Reinforced Earth Slope 8 a 2m deep and 5m wide (minimum) undercut was excavated into residual soil with an undrained shear strength greater than 75kPa to ensure a consistent subgrade. Uncontrolled Motorway Fill was discovered in the northwestern area of Stage 5 during the excavation for the undercut of Reinforced Earth Slope 8. Uncontrolled Motorway Fill overlying a buried topsoil layer was also discovered along the western site boundary within Lots 75 to 78. All Uncontrolled Motorway Fill was removed. The undercut was replaced with engineered, compacted fill, placed in accordance with the bulk earthworks specification (Section 2.3 above).

Construction of the eastern section of Reinforced Earth Slope 8 was completed in May 2019. settlement monitoring of this section of Reinforced Earth Slope 8 began in November 2019 and is ongoing at this date. No significant movement has been observed since monitoring began.

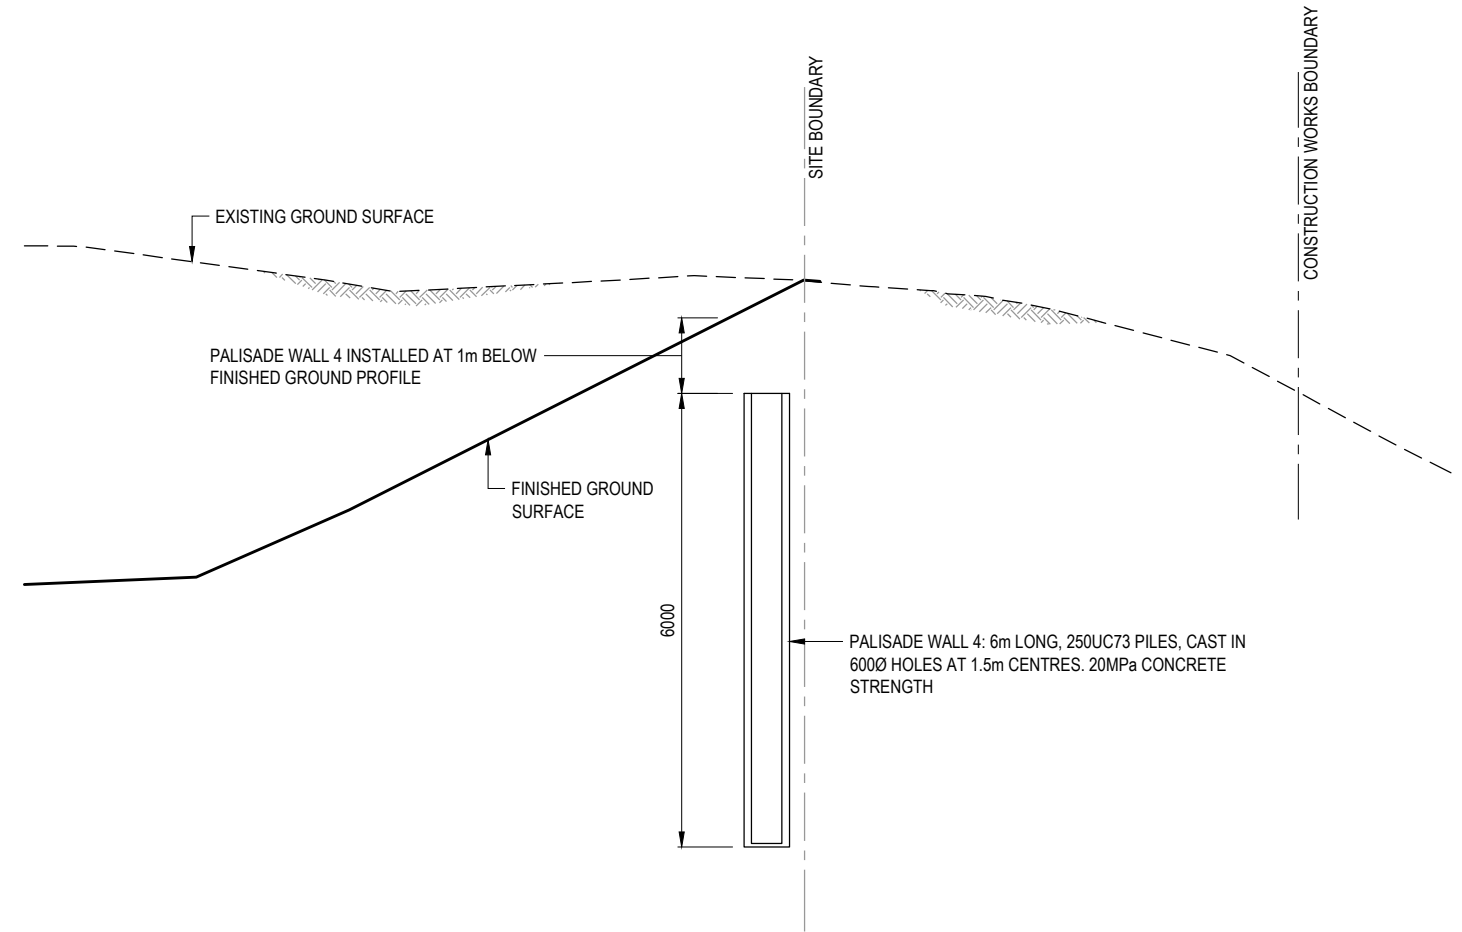
SECTION 9 PALISADE WALL 4 TYPICAL DETAIL  
SCALE 1:100

LEGEND	
---	EXISTING GROUND
—	PROPOSED GROUND PROFILE
- - - -	CONSTRUCTION WORKS BOUNDARY
- · - · -	SITE BOUNDARY
[Hatched Box]	HIGH STRENGTH STRUCTURAL FILL OR CONCRETE

Ground conditions exposed during construction of Palisade Walls 4 and 5 were generally as anticipated from the design stage of the development. The slope stability analysis results from the original design phase are discussed in Section 4.

During initial investigations it was found the western boundary of Stage 5 did not have an adequate factor of safety to prevent instability. To ensure the stability of the slope, Palisade Wall 4 has been constructed along the western boundary within Lots 65 to 74. A no build zone has also been delineated 5m back from the western site boundary across Lots 66 to 78, where a Vegetated Reinforced Earthbatter has been constructed. The extent of the Building Limitation Zones along the Stage 5 western boundary is shown on T+T Drawing 21854.0031–AHP5S5–120 (Building Limitation Plan) in Appendix B.

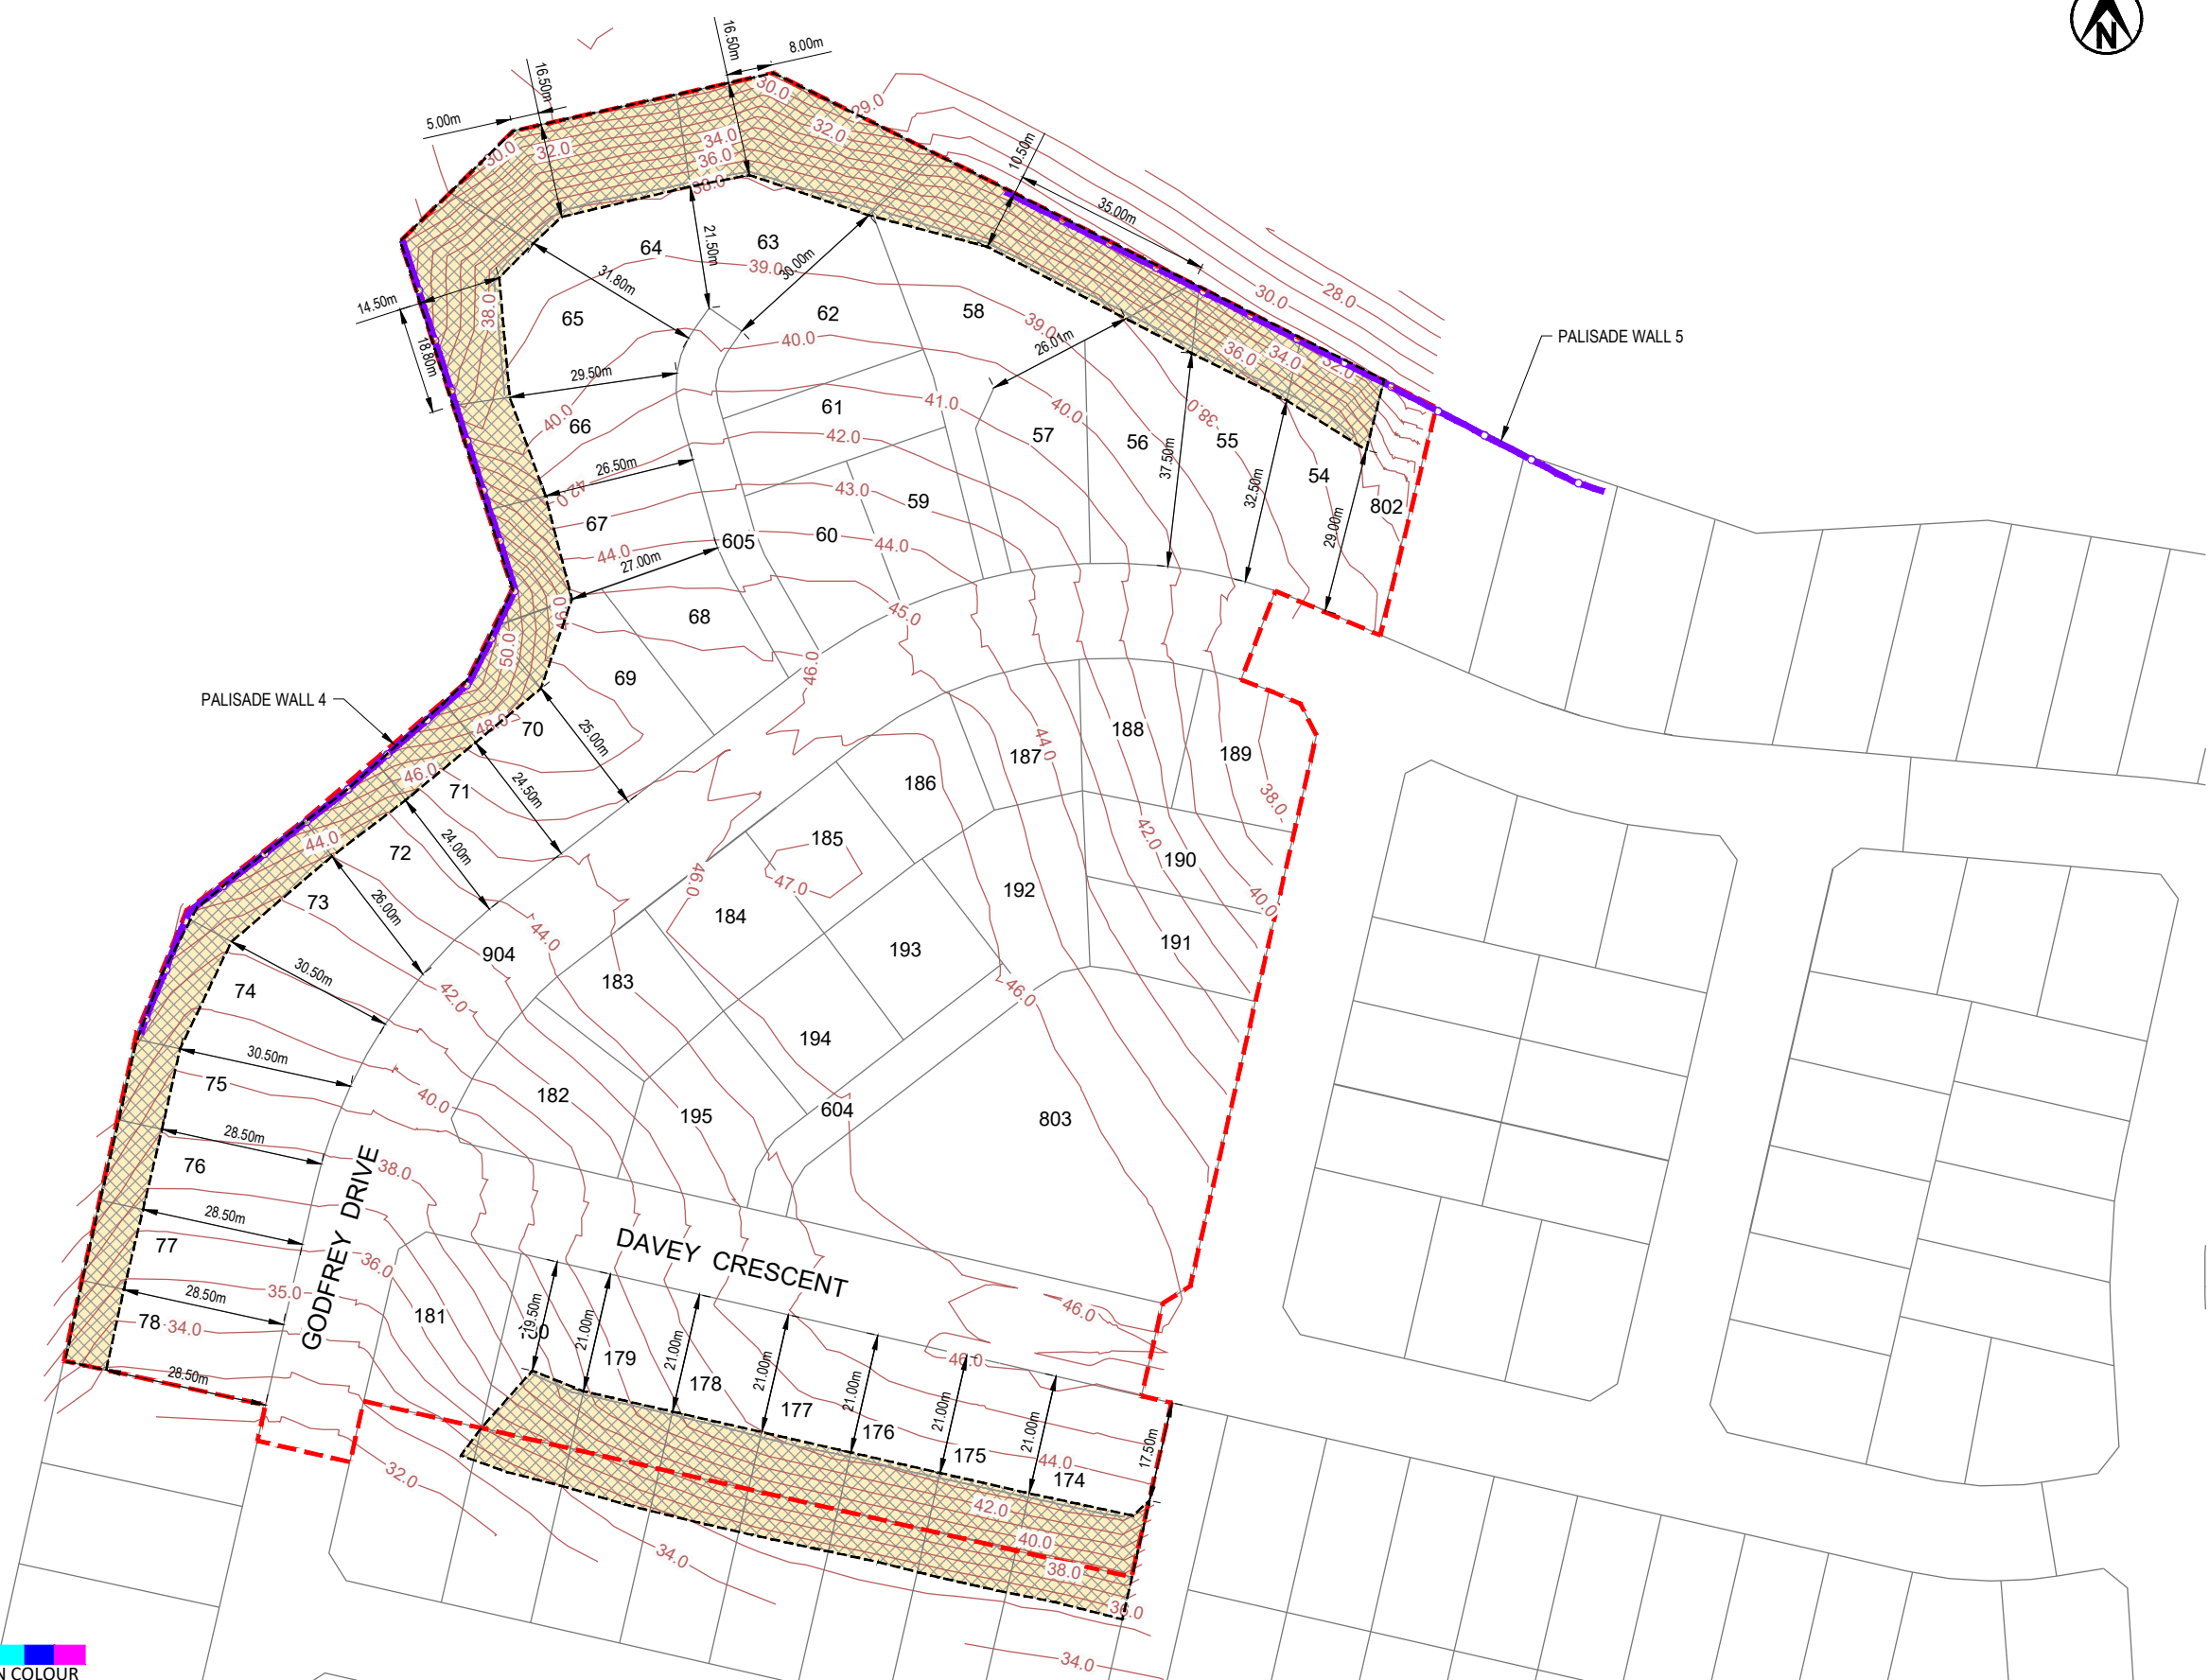
CLIENT	<b>WFH PROPERTIES LTD</b>
PROJECT	<b>MILLWATER - ARRANS HILL</b>
TITLE	<b>PRECINCT 5 STAGE 5 BUILDING LIMITATION PLAN</b>
SCALE (A3)	1:1250
DWG No.	21854.0031-AHP5S5-120
REV	1

- STAGE 5 BOUNDARY
- 94 LOT BOUNDARIES
- 35.0 FINISHED GROUND PROFILE (1m INTERVAL)
- 250UC73 PILES
- BUILDING LIMITATION ZONE

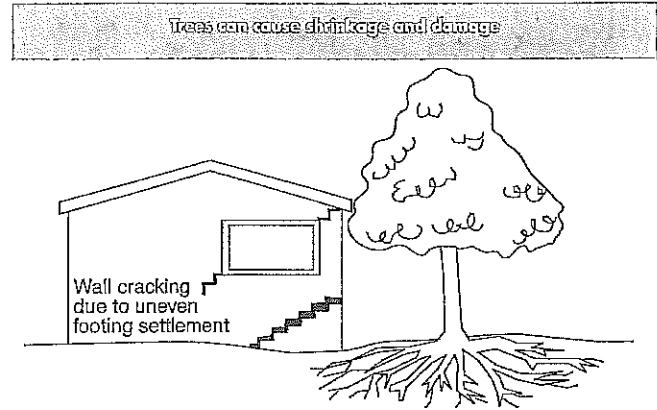
As the moisture absorption process completes its journey to the innermost areas of the building, the internal footings will rise. If the spread of moisture is roughly even, it may be that the symptoms will temporarily disappear, but it is more likely that swelling will be uneven, creating a difference rather than a disappearance in symptoms. In buildings with timber flooring supported by bearers and joists, the isolated piers will rise more easily than the strip footings or piers under walls, creating noticeable doming of flooring.

As the weather pattern changes and the soil begins to dry out, the external footings will be first affected, beginning with the locations where the sun's effect is strongest. This has the effect of lowering the external footings. The doming is accentuated and cracking reduces or disappears where it occurred because of dishing, but other cracks open up. The roof lines may become convex.
