**MILLWATER SUBDIVISION -  
ARRAN POINT PRECINCT 7  
STAGE 4**

**Geotechnical Completion Report**

**Prepared for**  
WFH Properties Ltd  
**Prepared by**  
Tonkin & Taylor Ltd  
**Date**  
November 2018  
**Job Number**  
21854.0037/APP7S4.v1

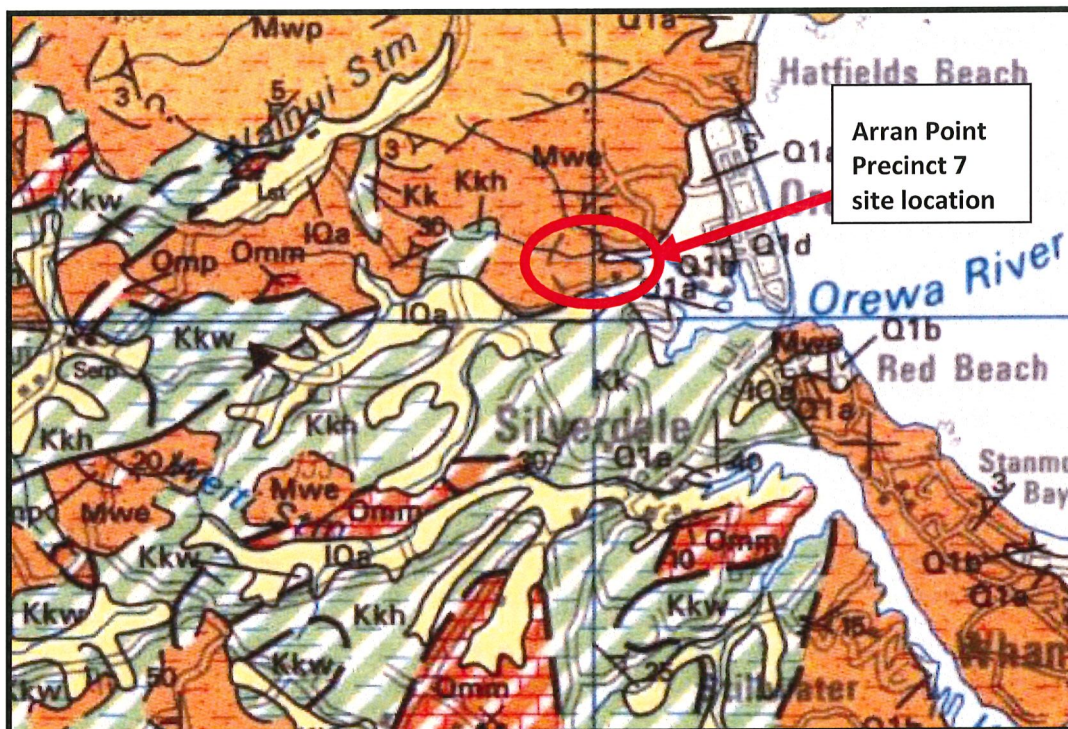
Figure 1 - Local Geology (from Edbrooke)

Published geological mapping and information indicates the Arran Point Precinct 7 area is underlain by East Coast Bays Formation (ECBF) materials. In addition to the ECBF materials, our investigations identified the presence of alluvial materials in isolated locations on site.
