**MILLWATER SUBDIVISION -
ARRANS HILL PRECINCT 5
STAGE 3A**

Geotechnical Completion Report

Prepared for
WFH Properties Ltd
Prepared by
Tonkin & Taylor Ltd
Date
October 2018
Job Number
21854.0031/AHP5S3A.v1

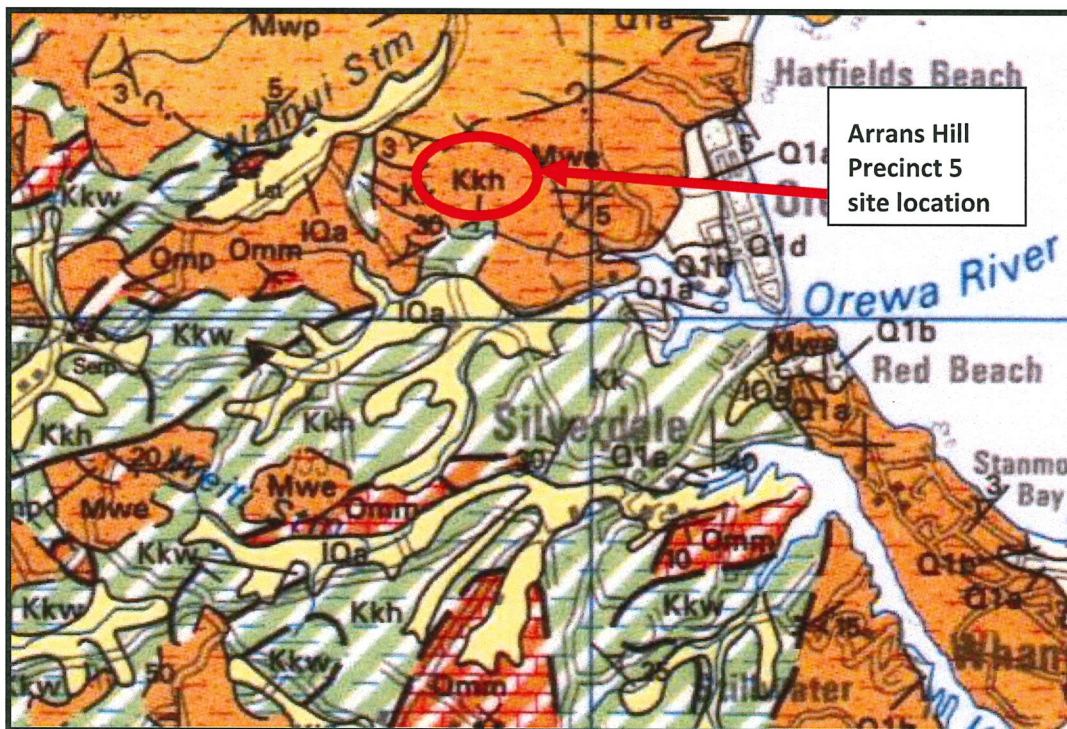
Figure 1 - Local Geology (from Edbrooke)

Published geological mapping and information indicates the Arrans Hill Precinct 5 area is underlain by East Coast Bays Formation (ECBF) materials. In addition to the ECBF materials, our investigations identified the presence of alluvial and colluvial materials on site along the stream margins.

Summary descriptions of geological units in the Arrans Point area (after Kermodé 1991) are as follows:

Alluvium and Colluvium are generally observed on the lower slopes, along the edges of the tidal tributaries of the Orewa River - along the southern and eastern boundary of the site. In places, it is locally discontinuous or absent.

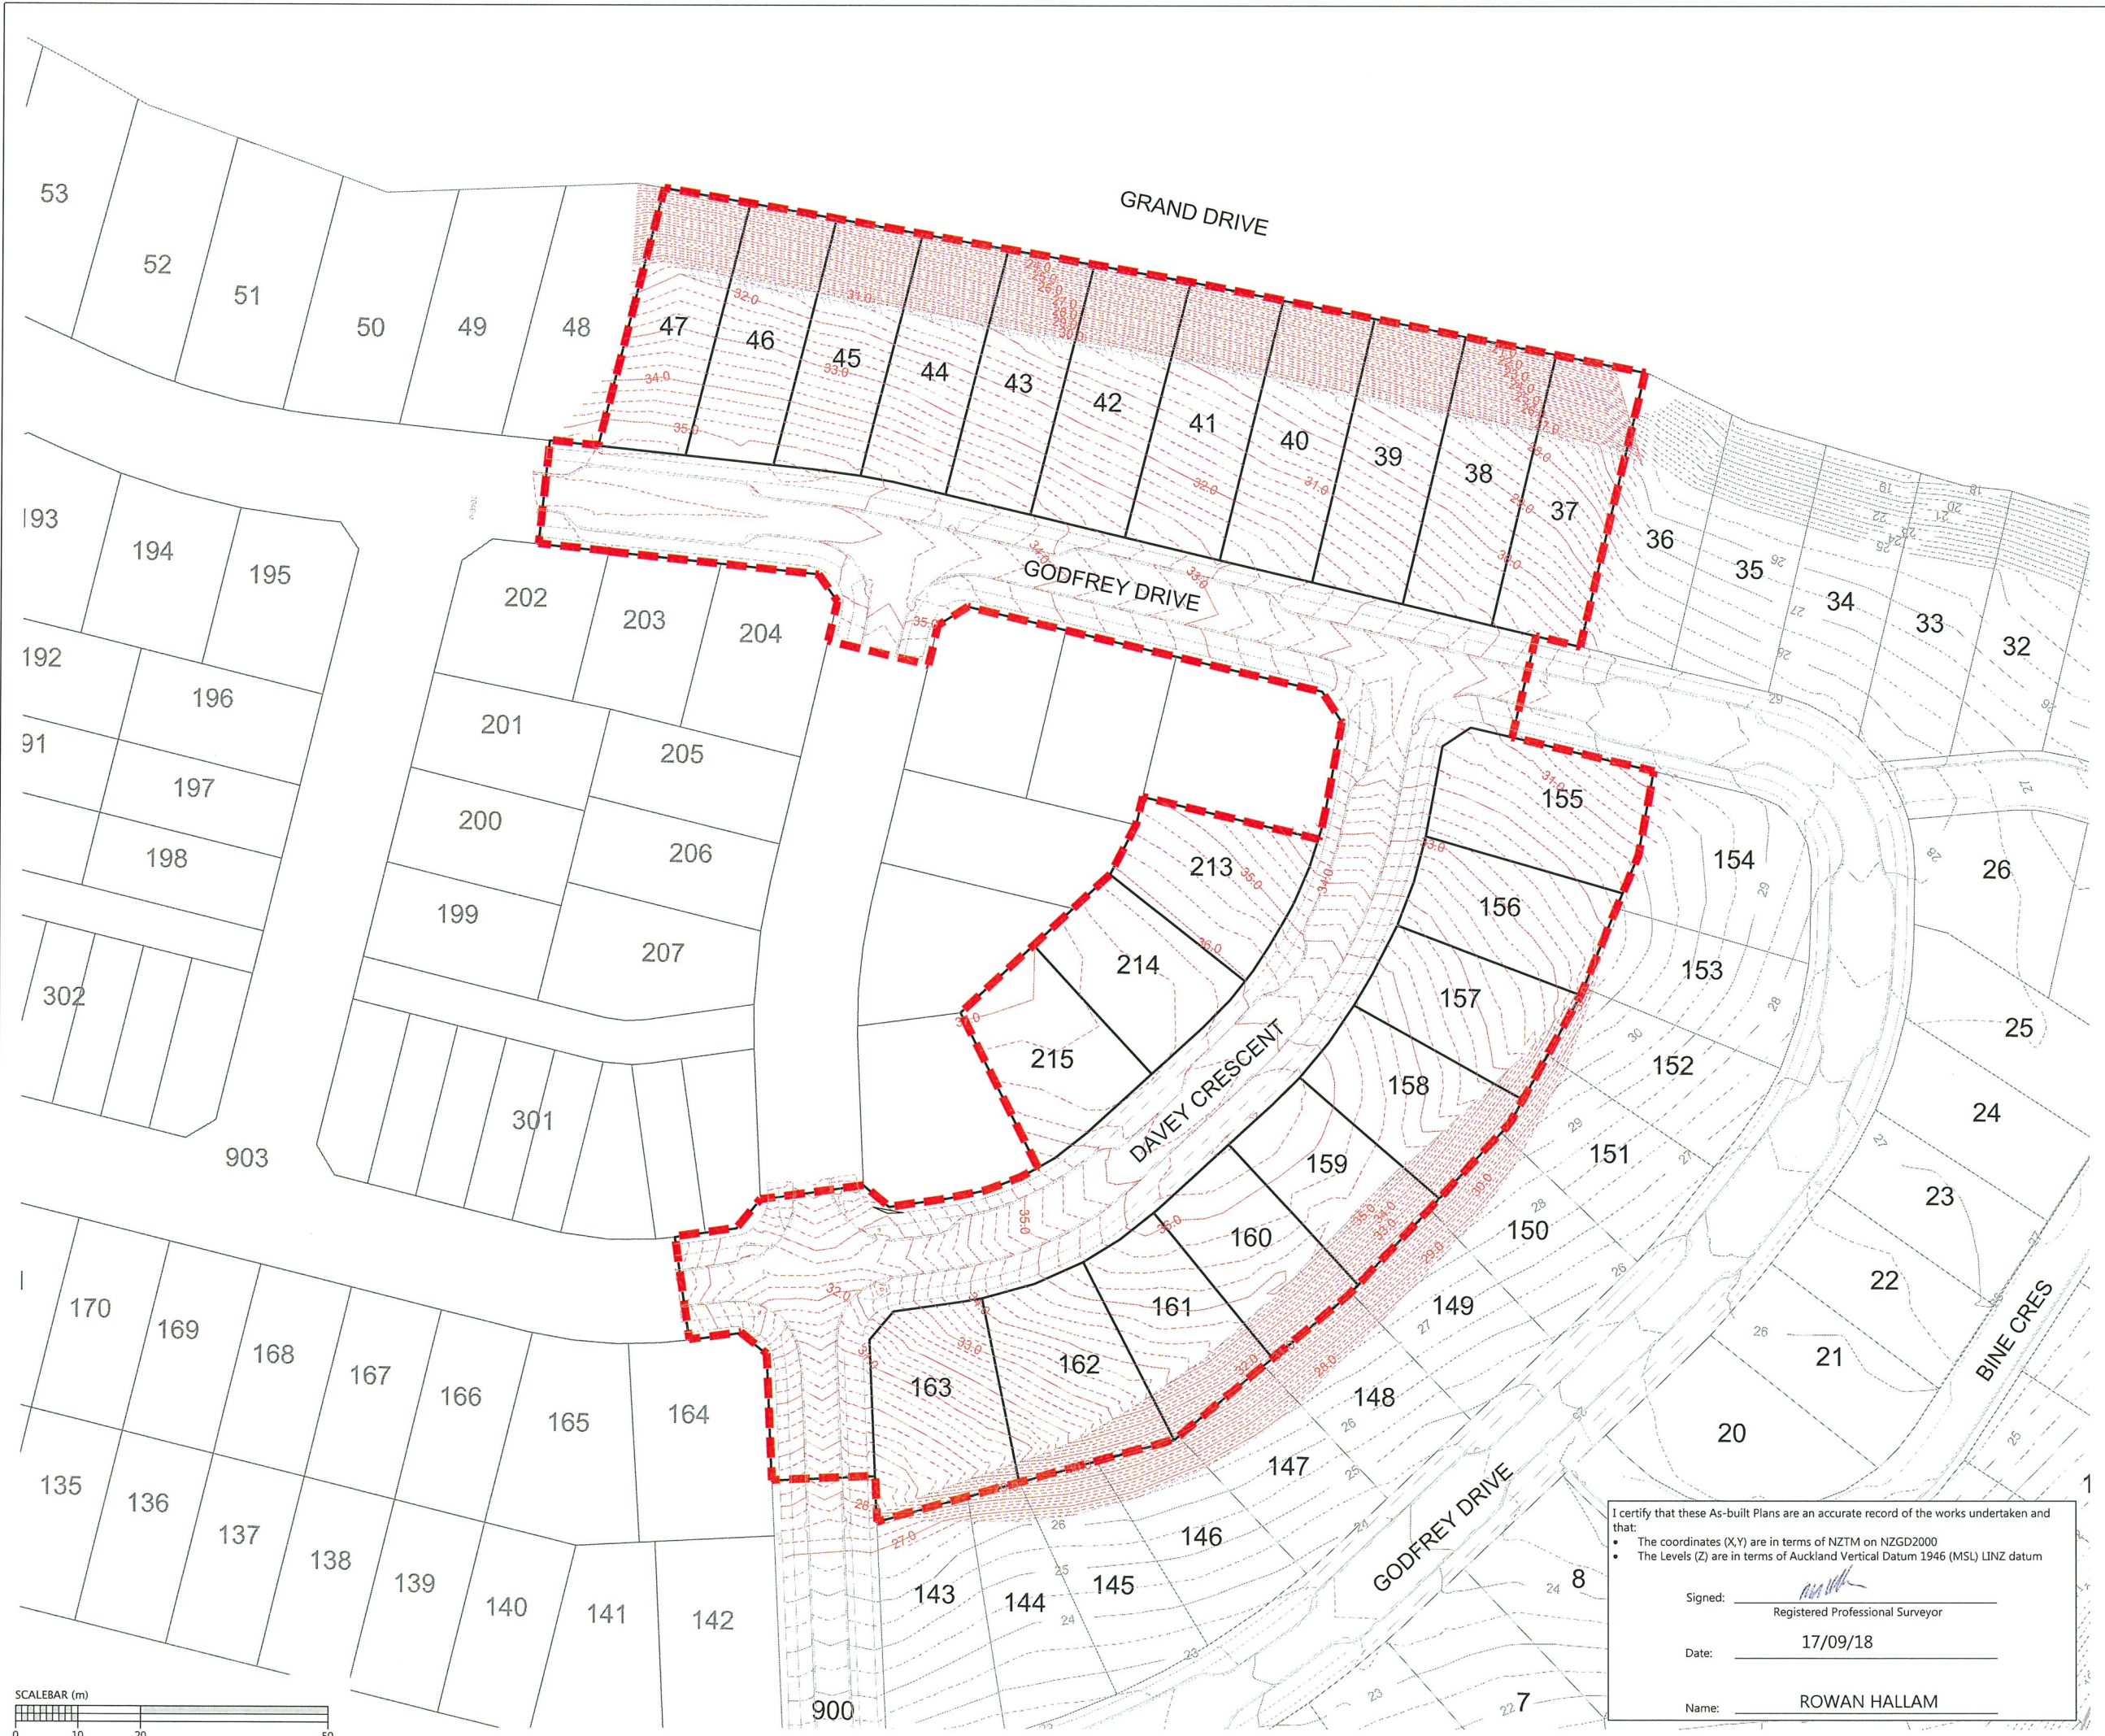
STATUS	ISSUED FOR INFORMATION	REV
SCALE	1:1000 @ A3	1
COUNCIL	AUCKLAND COUNCIL	
DWG NO	37503-03A-100-AB

NOTES
 1. NEW CONTOURS ARE AT 0.25m INTERVALS

- 37503-03A-100-AB Final Contour AsBuilt Plan
- 37503-03A-110-AB Cut & Fill As-Built – Original to Lowest Surface
- 37503-03A-111-AB Cut & Fill As-Built – Lowest to Final Surface
- 37503-03A-112-AB Cut & Fill As-Built – Original to Final Surface
- 37503-03A-120-AB Shear Key, Undercut and Subsoil Drain AsBuilt Plan
- 37503-03A-140-AB Reinforced Earth Batter & Slope Stabilisation Plan
- 37503-03A-300-AB to -302-AB Stormwater As-Built Plans
- 37503-03A-400-AB to -402-AB Wastewater As-Built Plans

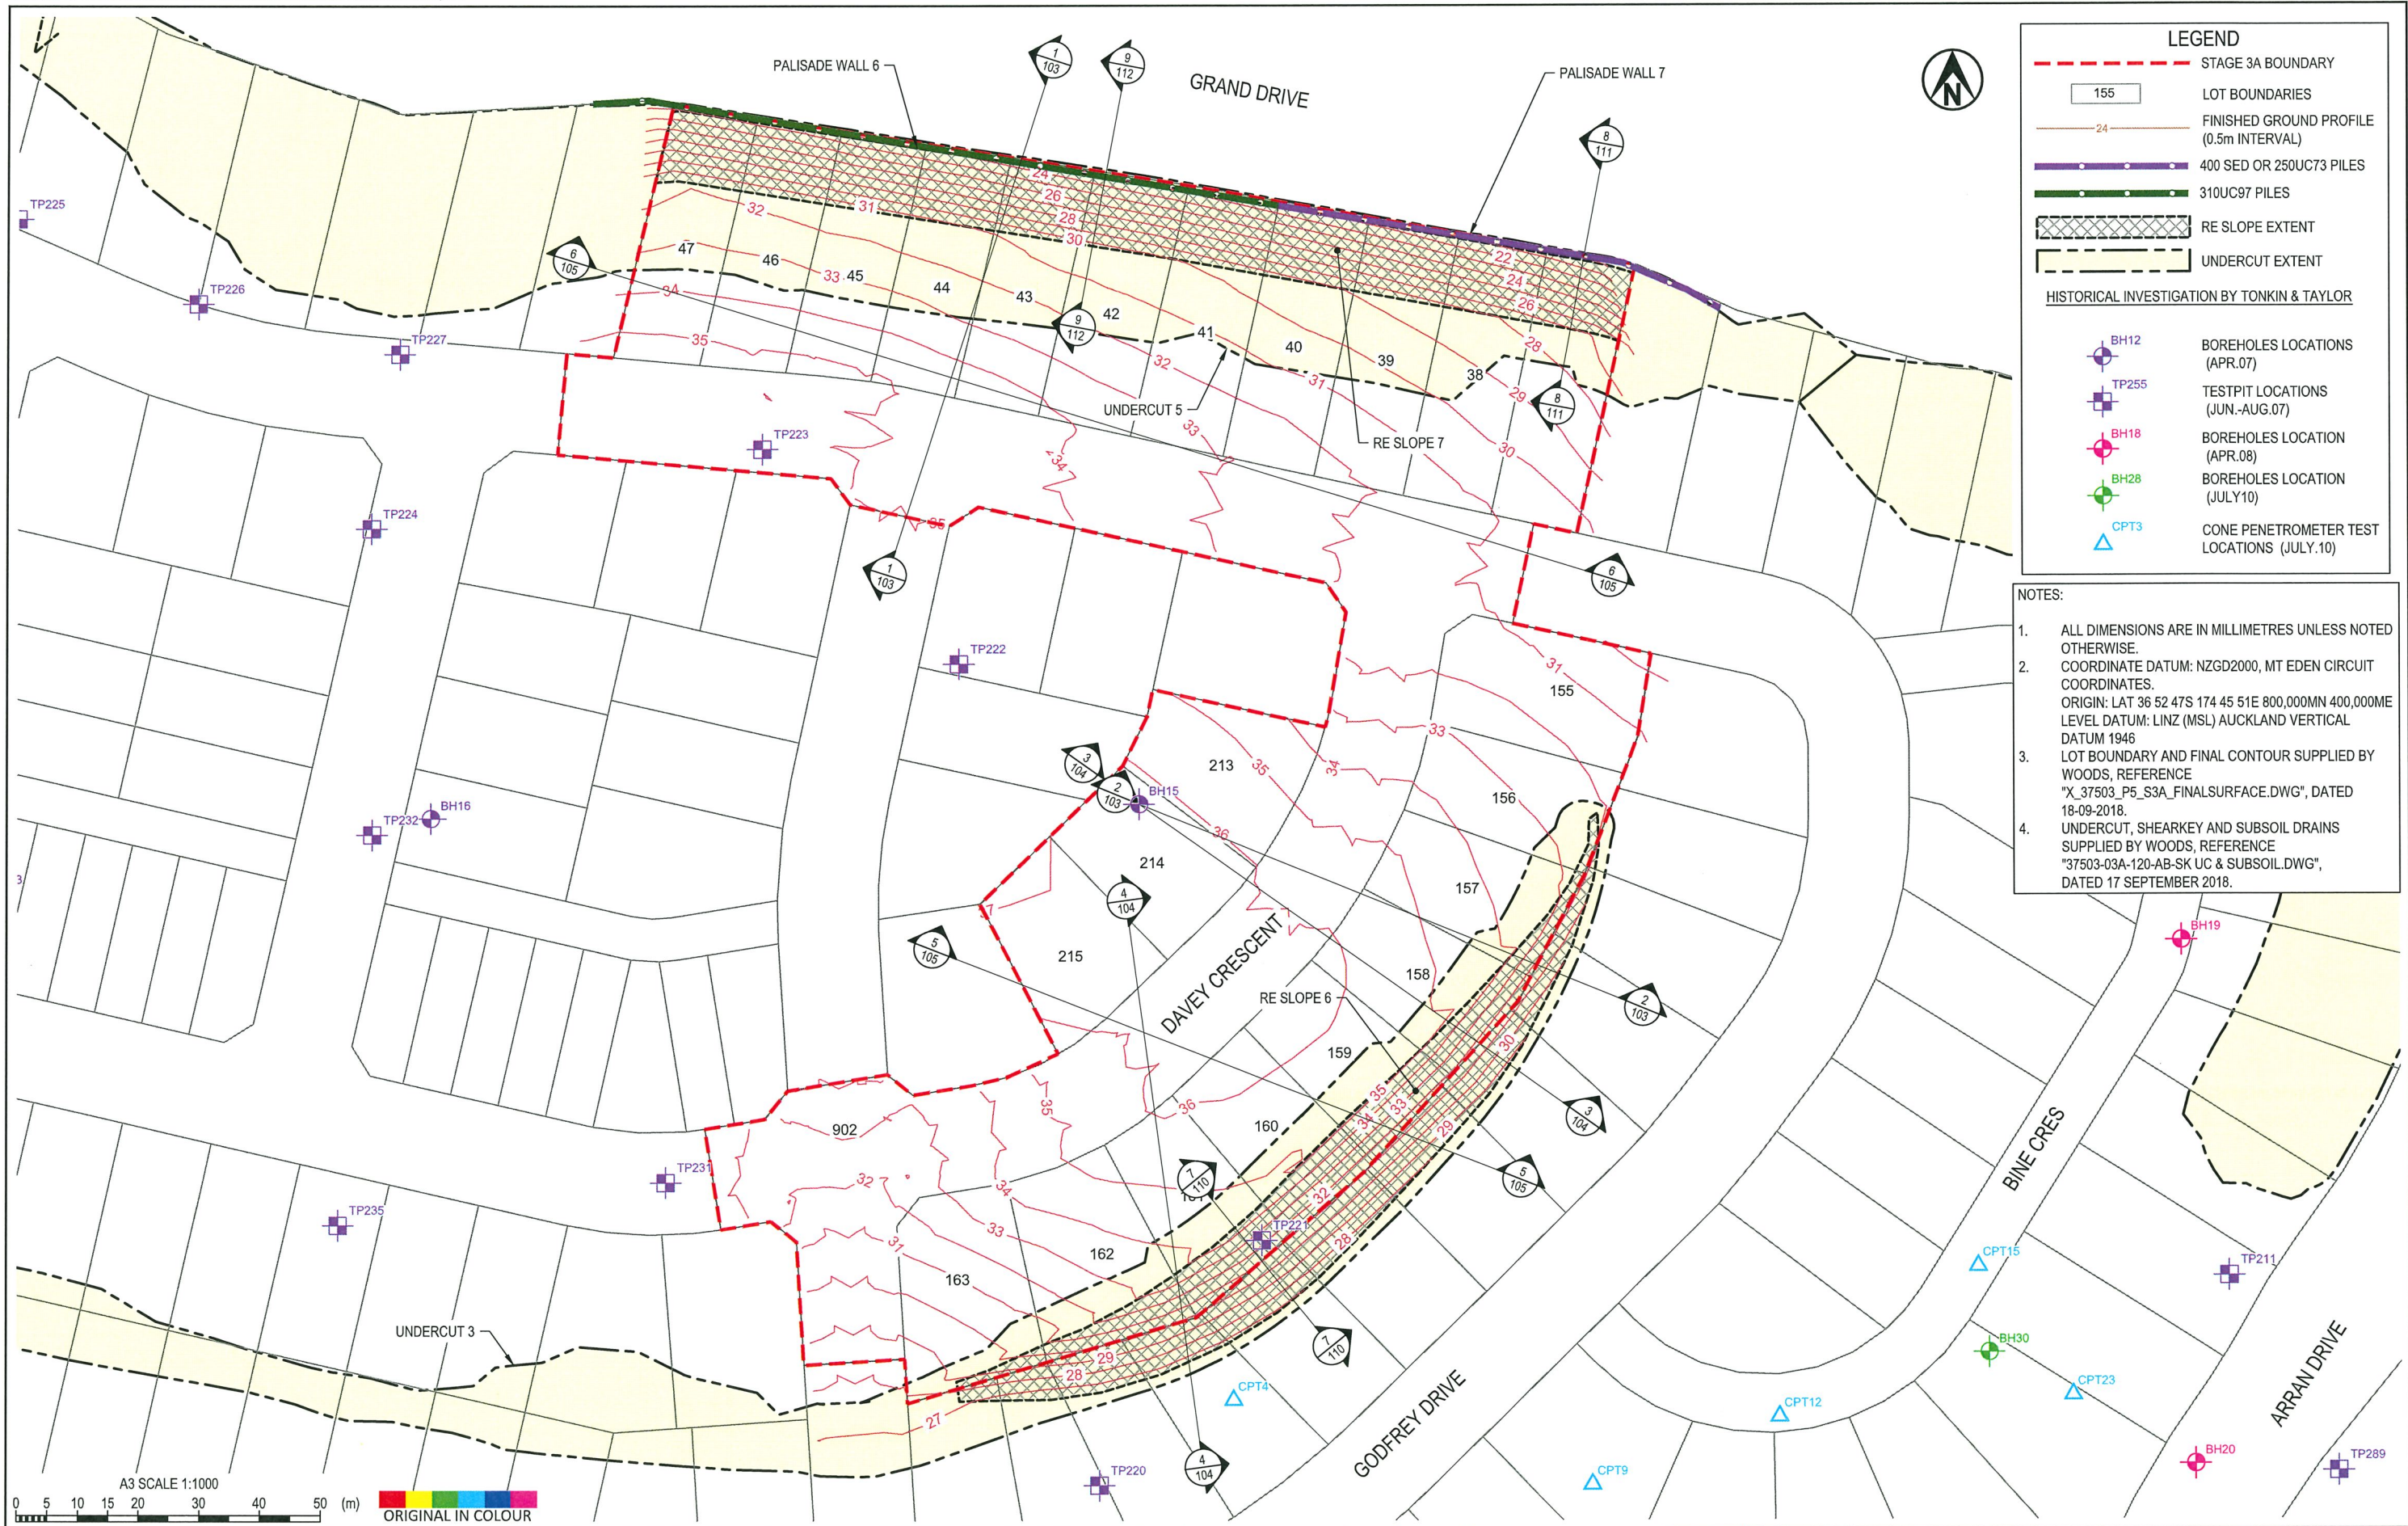
CLIENT	WFH PROPERTIES LTD
PROJECT	MILLWATER - ARRANS HILL
TITLE	PRECINCT 5 STAGE 3A GEOTECHNICAL WORKS PLAN
SCALE (A3)	1:1000
DWG No.	21854.0031-AHP5S3A-101
REV	1

- LEGEND**
- STAGE 3A BOUNDARY
 - LOT BOUNDARIES
 - FINISHED GROUND PROFILE (0.5m INTERVAL)
 - 400 SED OR 250UC73 PILES
 - 310UC97 PILES
 - RE SLOPE EXTENT
 - UNDERCUT EXTENT

- HISTORICAL INVESTIGATION BY TONKIN & TAYLOR**
- BH12 BOREHOLES LOCATIONS (APR.07)
 - TP255 TESTPIT LOCATIONS (JUN.-AUG.07)
 - BH18 BOREHOLES LOCATION (APR.08)

Undercuts (minimum 2m deep and 5m wide) were excavated below the toe of RE 6 and RE 7 to ensure a consistent subgrade. The undercut was replaced with engineered, compacted fill, placed in accordance with the bulk earthworks specification (Section 2.3 above).

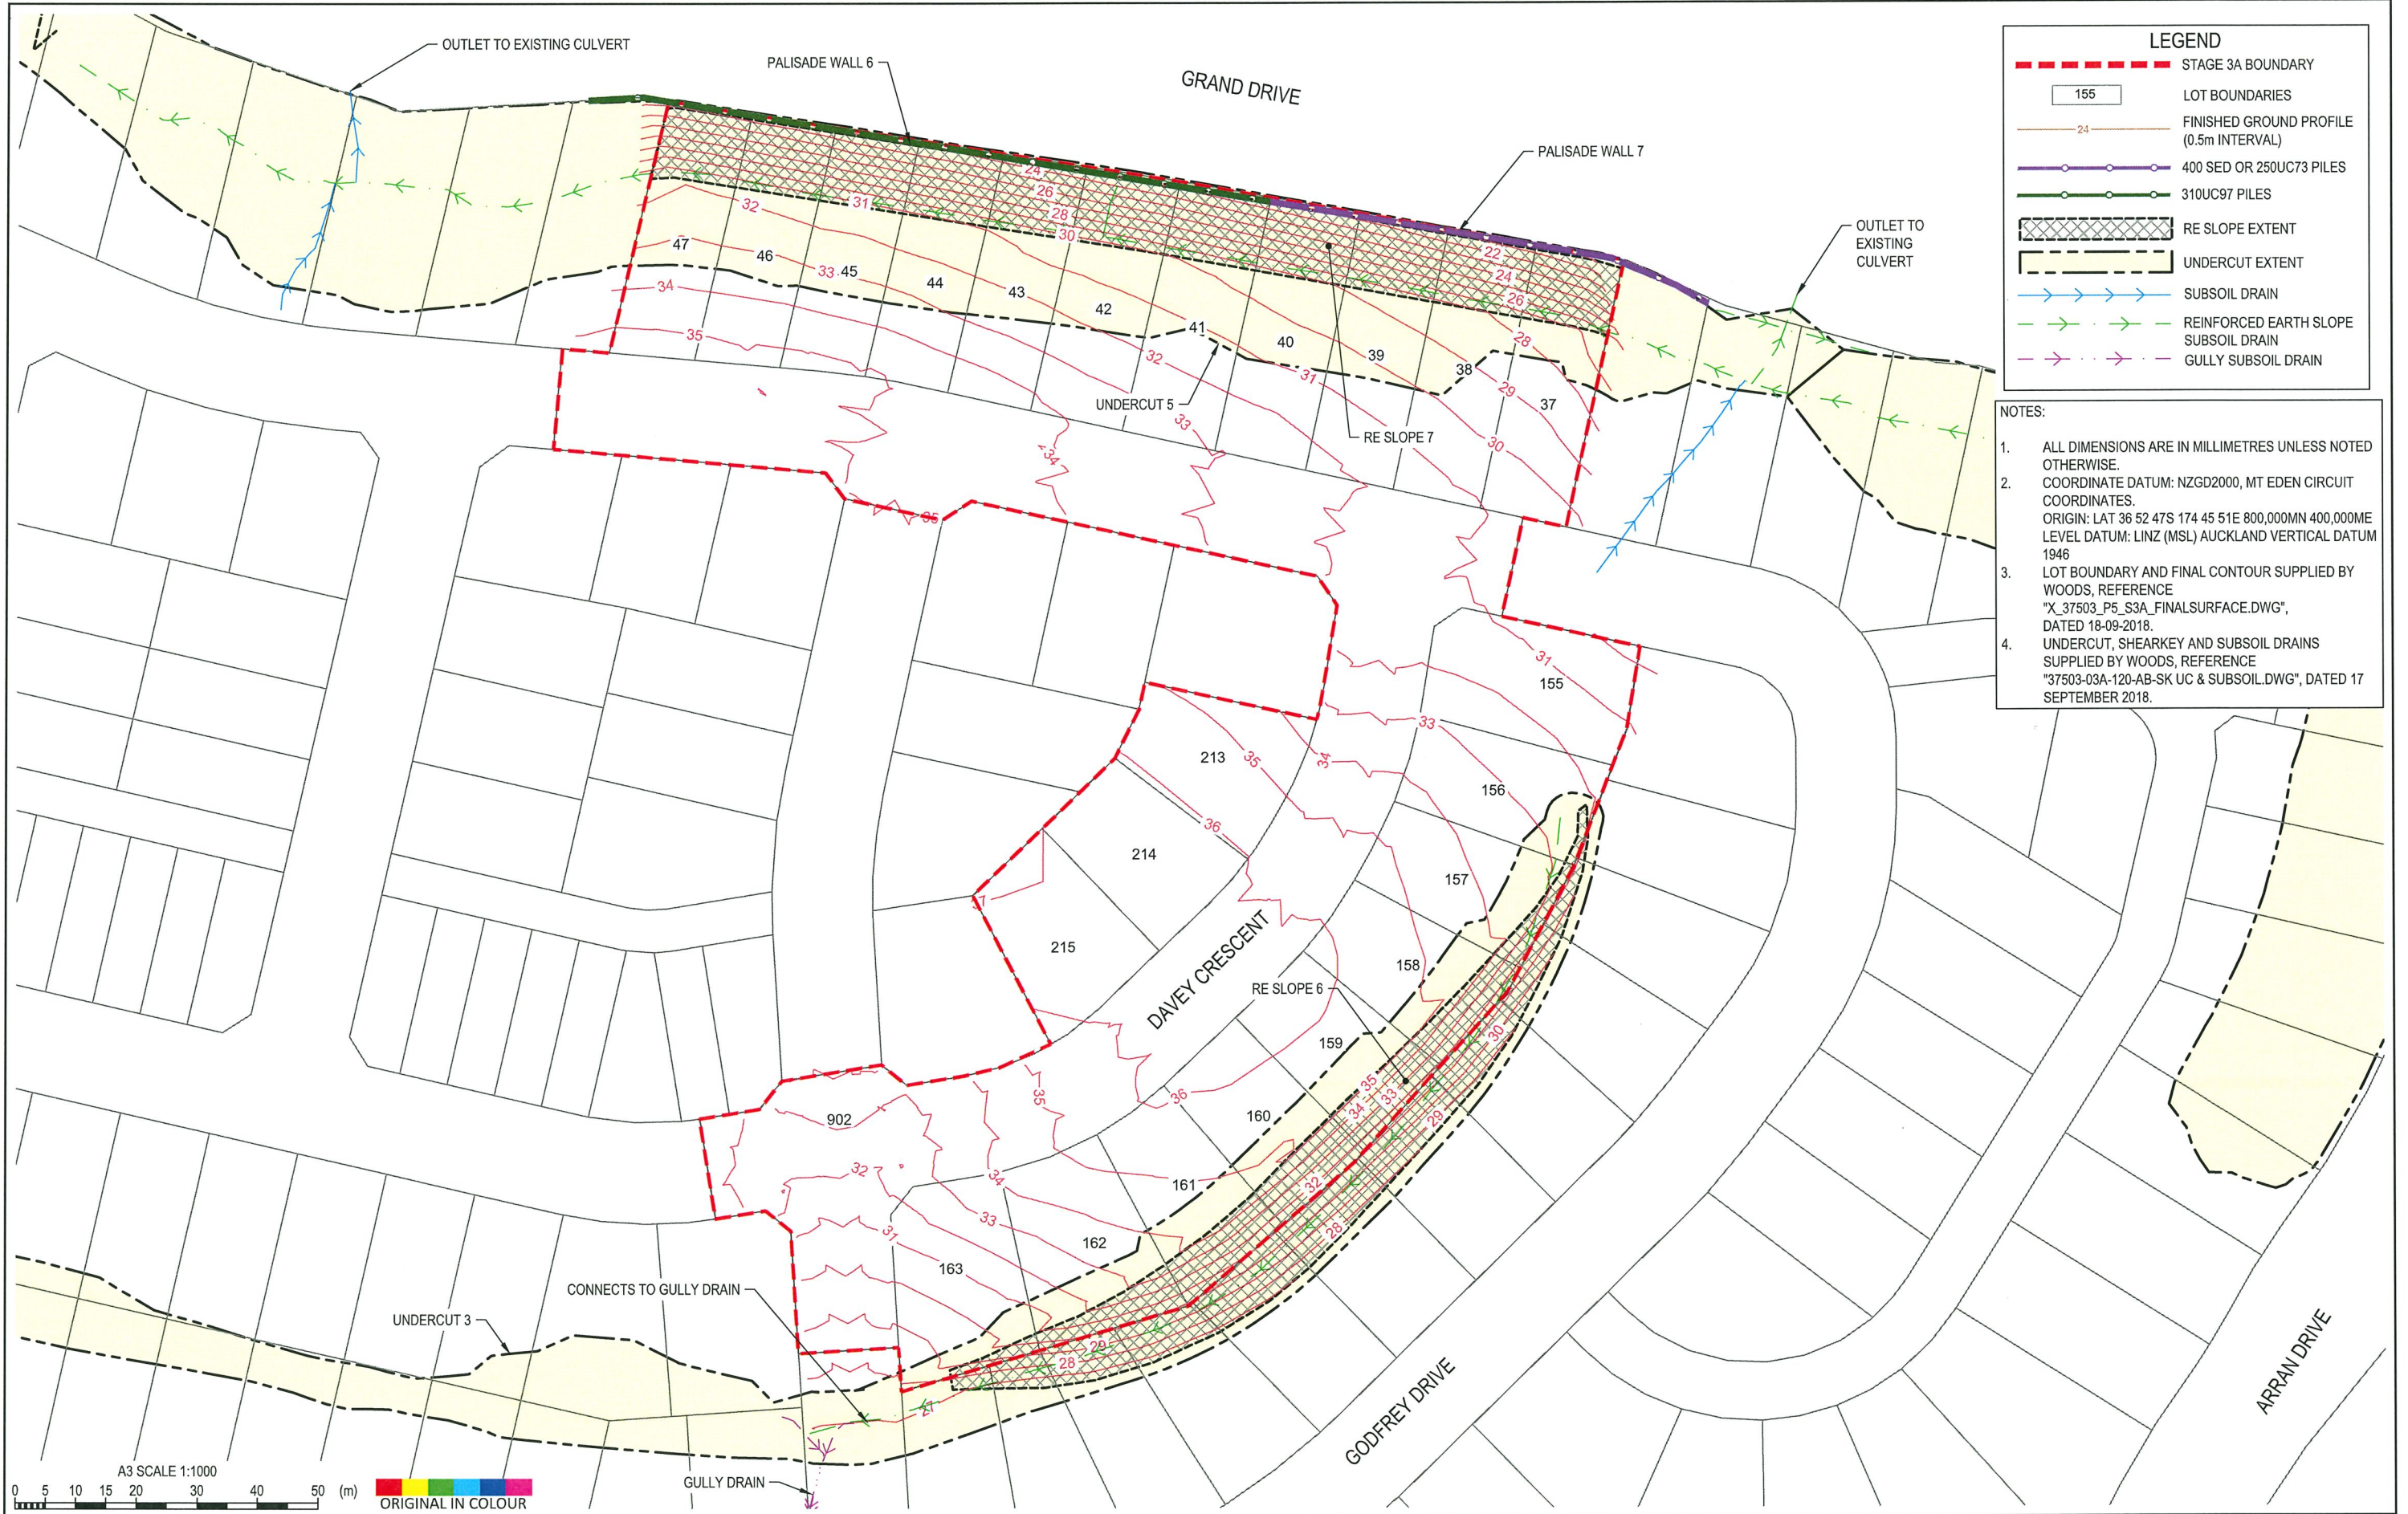
LEGEND

- - - - STAGE 3A BOUNDARY
- 155 LOT BOUNDARIES
- FINISHED GROUND PROFILE (0.5m INTERVAL)
- 400 SED OR 250UC73 PILES
- 310UC97 PILES
- RE SLOPE EXTENT
- UNDERCUT EXTENT
- SUBSOIL DRAIN
- REINFORCED EARTH SLOPE SUBSOIL DRAIN
- GULLY SUBSOIL DRAIN

As noted in Section 3.1, a drainage blanket was installed at the rear of the reinforced block of soil and comprises a minimum of 300mm thickness of SAP50 scoria, covered in Bidim A19 geotextile filtercloth and a cap of engineered cohesive fill 2m in thickness. A 160mm diameter Novaflo pipe at the base of the drainage blanket provides regular discharge outlets for any groundwater captured in the drainage blanket. These pipes are connected into the reticulated stormwater system (RE 6) or into the swale drain below Grand Drive (RE 7).

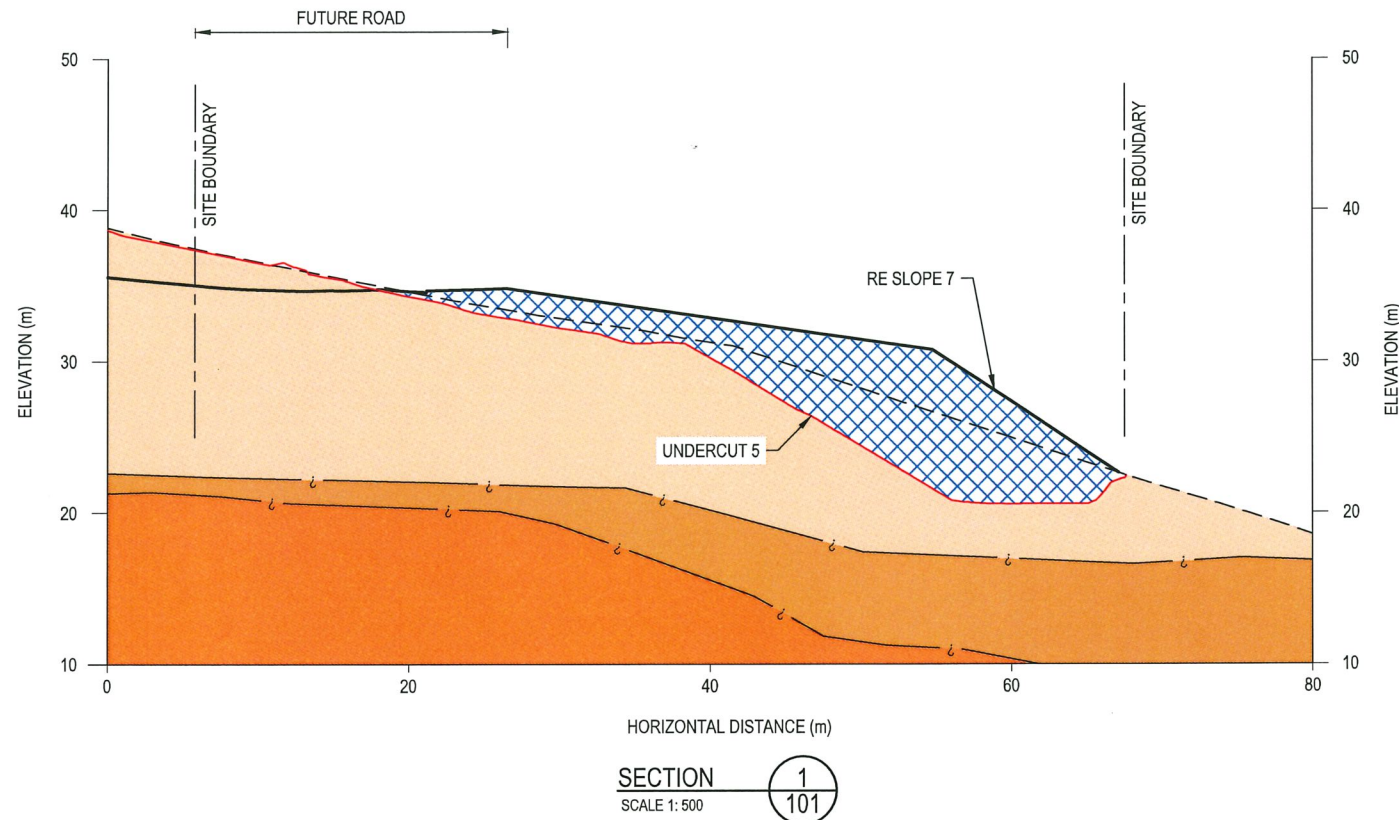
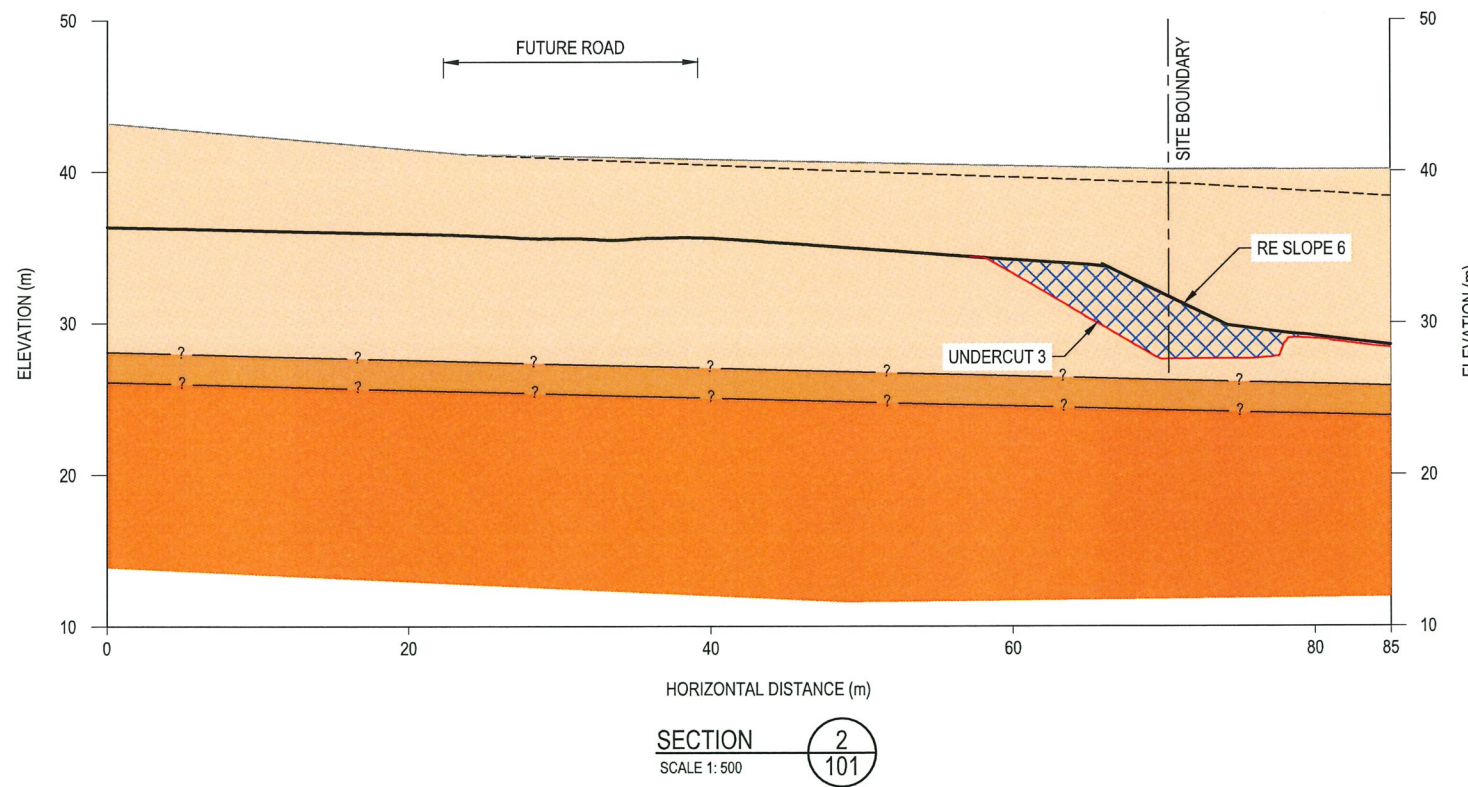
CLIENT	WFH PROPERTIES LTD
PROJECT	MILLWATER - ARRANS HILL
TITLE	PRECINCT 5 STAGE 3A GEOLOGICAL CROSS SECTIONS 1 & 2
SCALE (A3)	1:500
DWG No.	21854.0031-AHP5S3A-103
REV	1

NOTE:
1. ALL GEOLOGICAL BOUNDARIES ARE APPROXIMATE AND INFERRED FROM POINT LOCATION DATA.

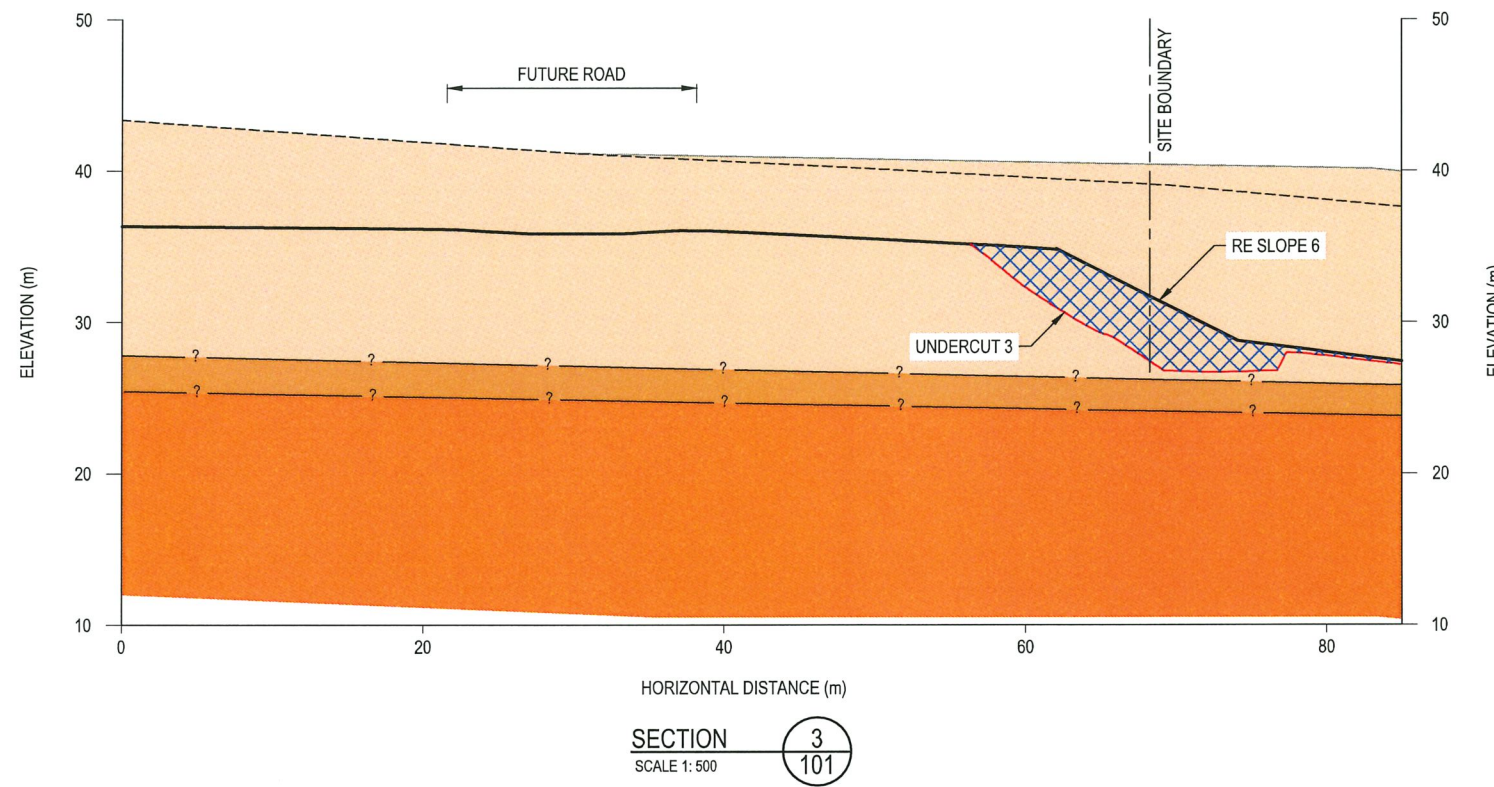
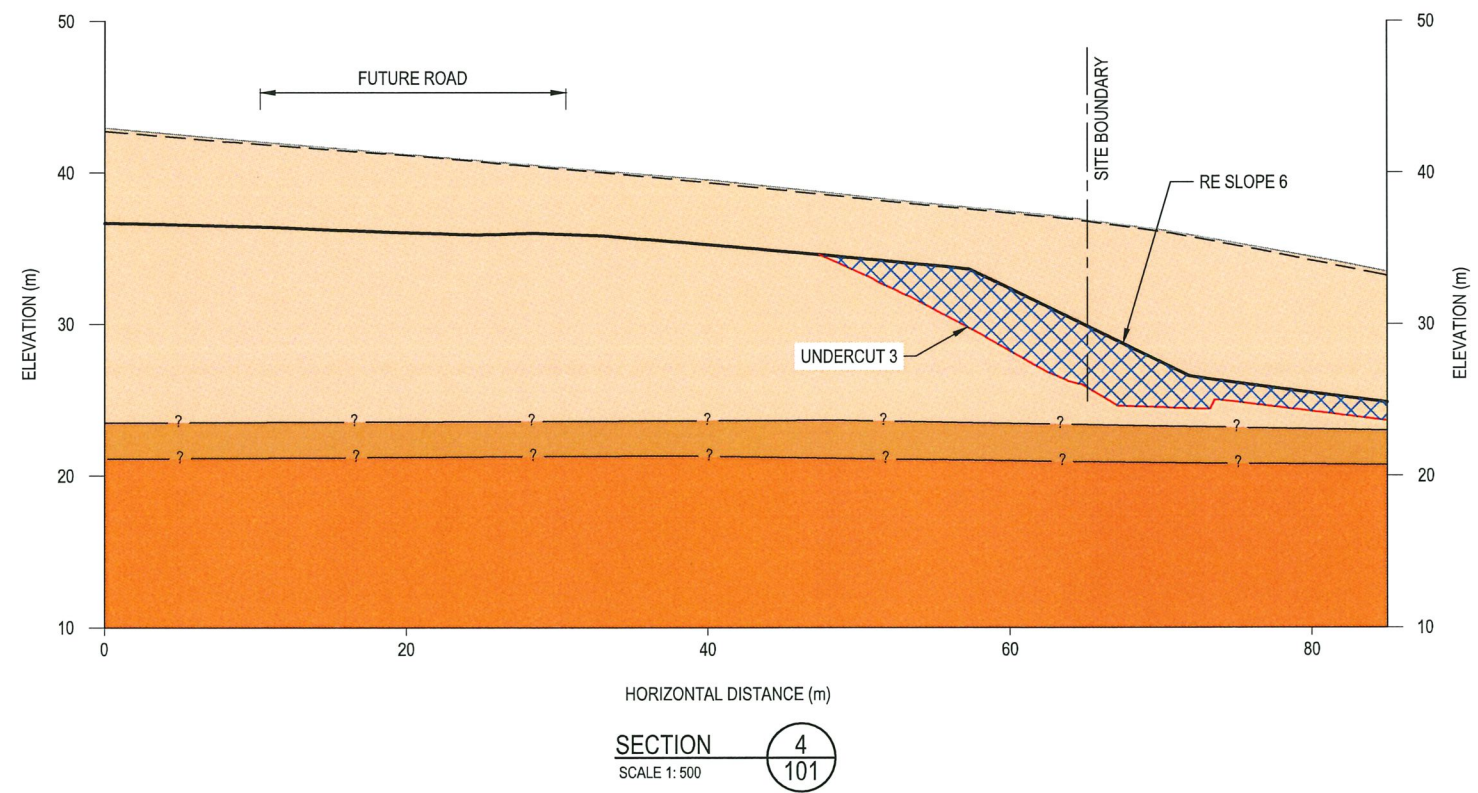
CLIENT	WFH PROPERTIES LTD
PROJECT	MILLWATER - ARRANS HILL
TITLE	PRECINCT 5 STAGE 3A GEOLOGICAL CROSS SECTIONS 3 & 4
SCALE (A3)	1:500
DWG No.	21854.0031-AHP5S3A-104
REV	1

LEGEND

- ORIGINAL GROUND PROFILE
- - - GROUND PROFILE PRIOR TO PRECINCT 5 COMMENCEMENT
- FINAL GROUND PROFILE
- ? — GEOLOGICAL CONTACT
- [Cross-hatched] ENGINEERED FILL
- [Light Orange] RESIDUAL-WEATHERED ECBF
- [Dark Orange] HIGHLY WEATHERED ECBF
- [Red-Orange] SLIGHTLY WEATHERED ECBF

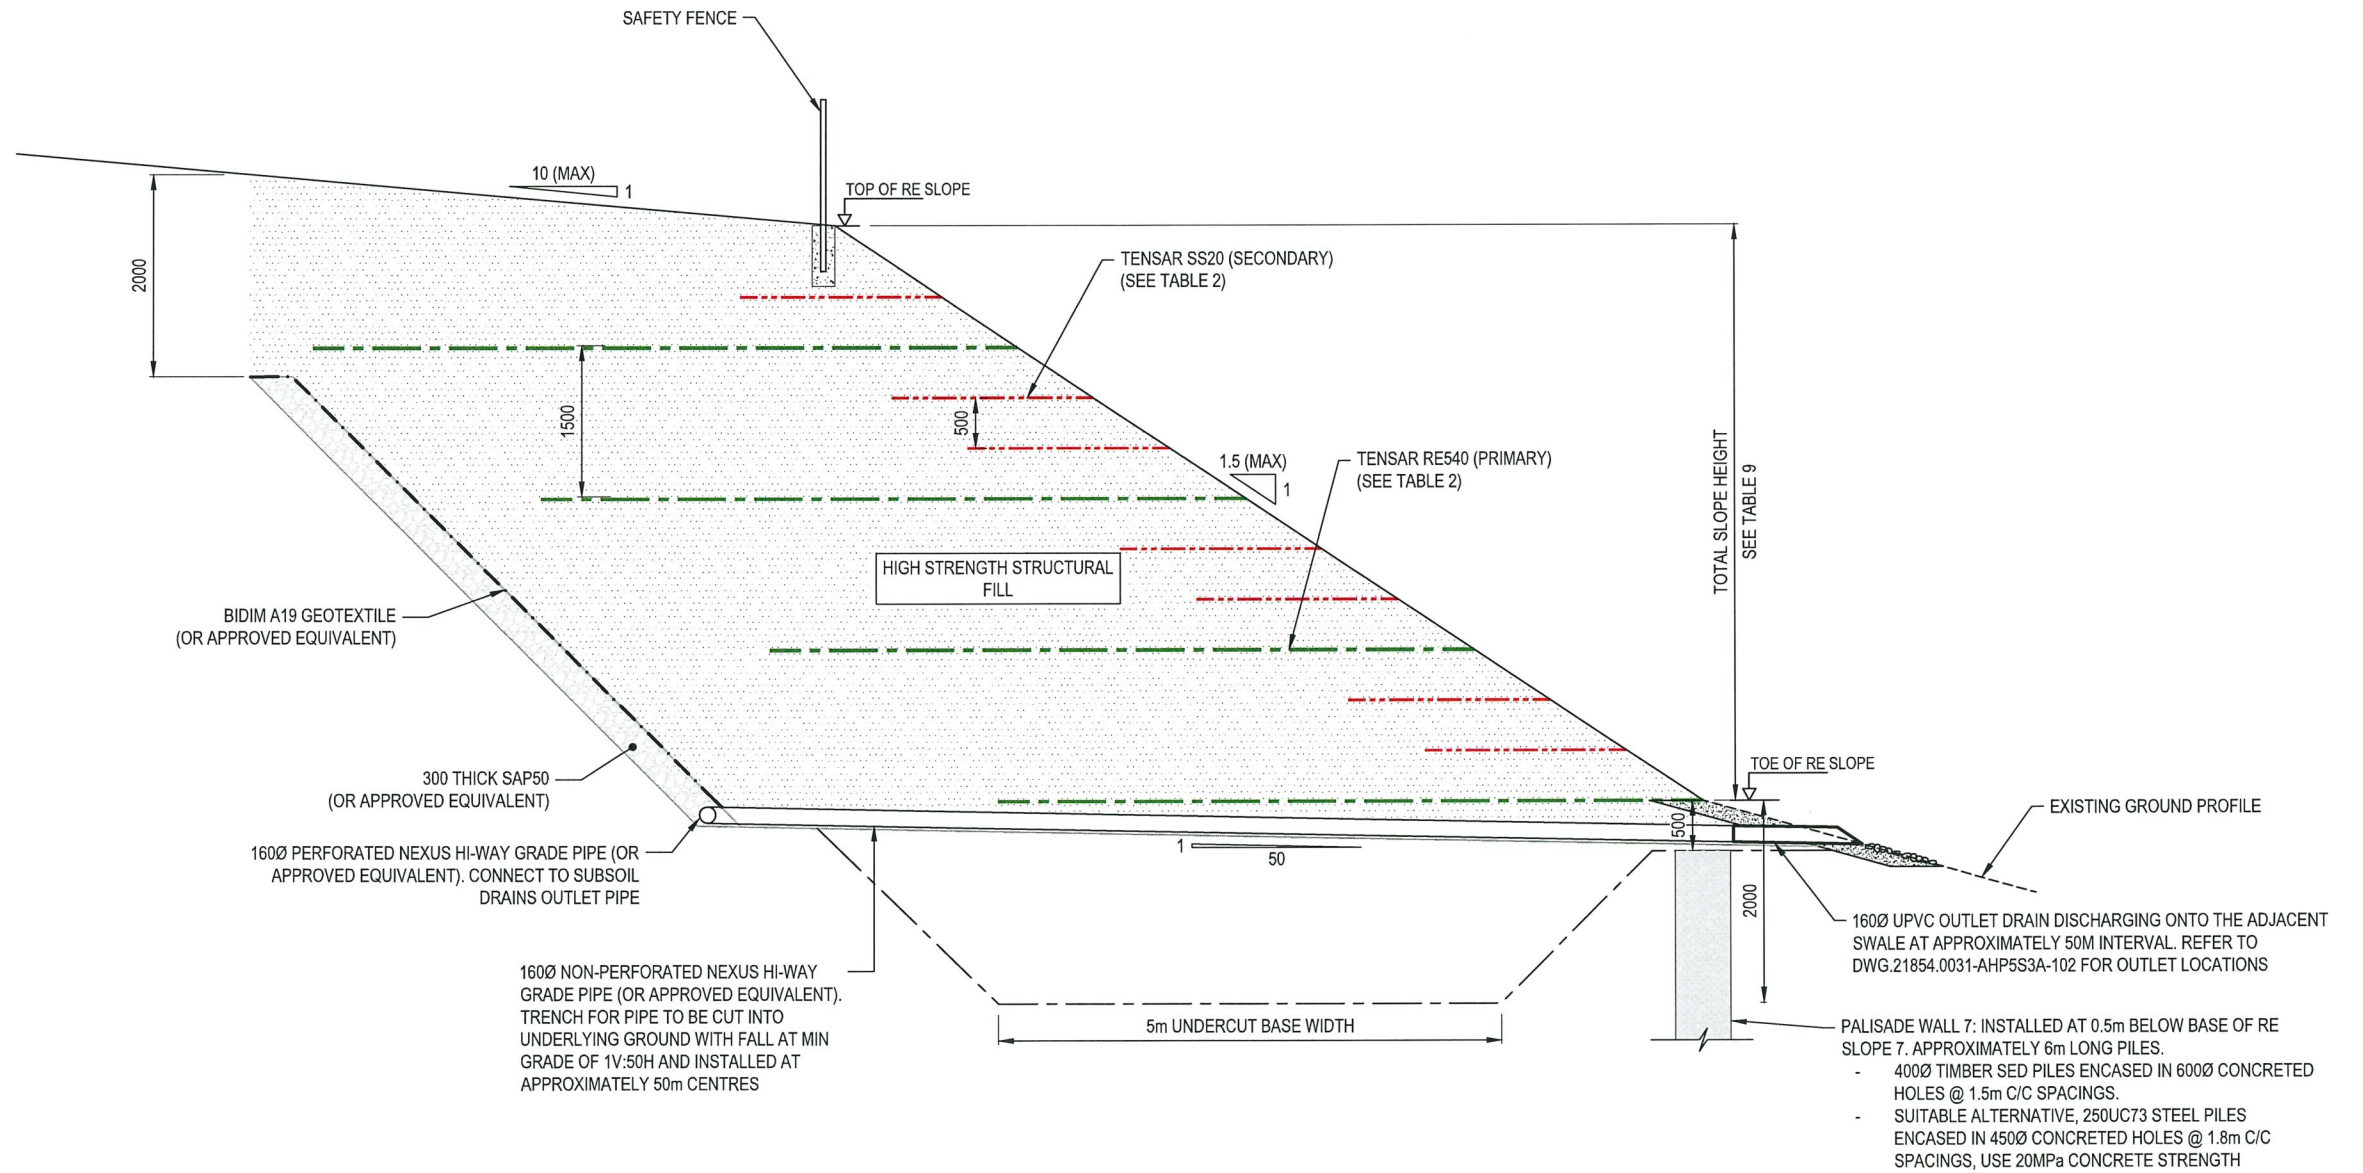
SECTION 8 RE SLOPE 7 WITH PALISADE WALL 7
SCALE 1:75

- ALL DIMENSIONS ARE IN MILLIMETRES UNLESS NOTED OTHERWISE.
- WALL SETOUT AS PROVIDED BY WOODS AND CONFIRMED ON SITE BY THE ENGINEER.
- SEE DWG.21854.0031-AHP5S3A-101 FOR RE SLOPE 7 PLAN.

LEGEND	
	BIDIM A19 GEOTEXTILE
	TENSAR SS20 (SECONDARY)
	TENSAR RE540 (PRIMARY)
	HIGH STRENGTH STRUCTURAL FILL
	SAP50 SCORIA
