**MILLWATER SUBDIVISION -
ARRANS HILL PRECINCT 5
STAGE 3A**

Geotechnical Completion Report

Prepared for
WFH Properties Ltd
Prepared by
Tonkin & Taylor Ltd
Date
October 2018
Job Number
21854.0031/AHP5S3A.v1

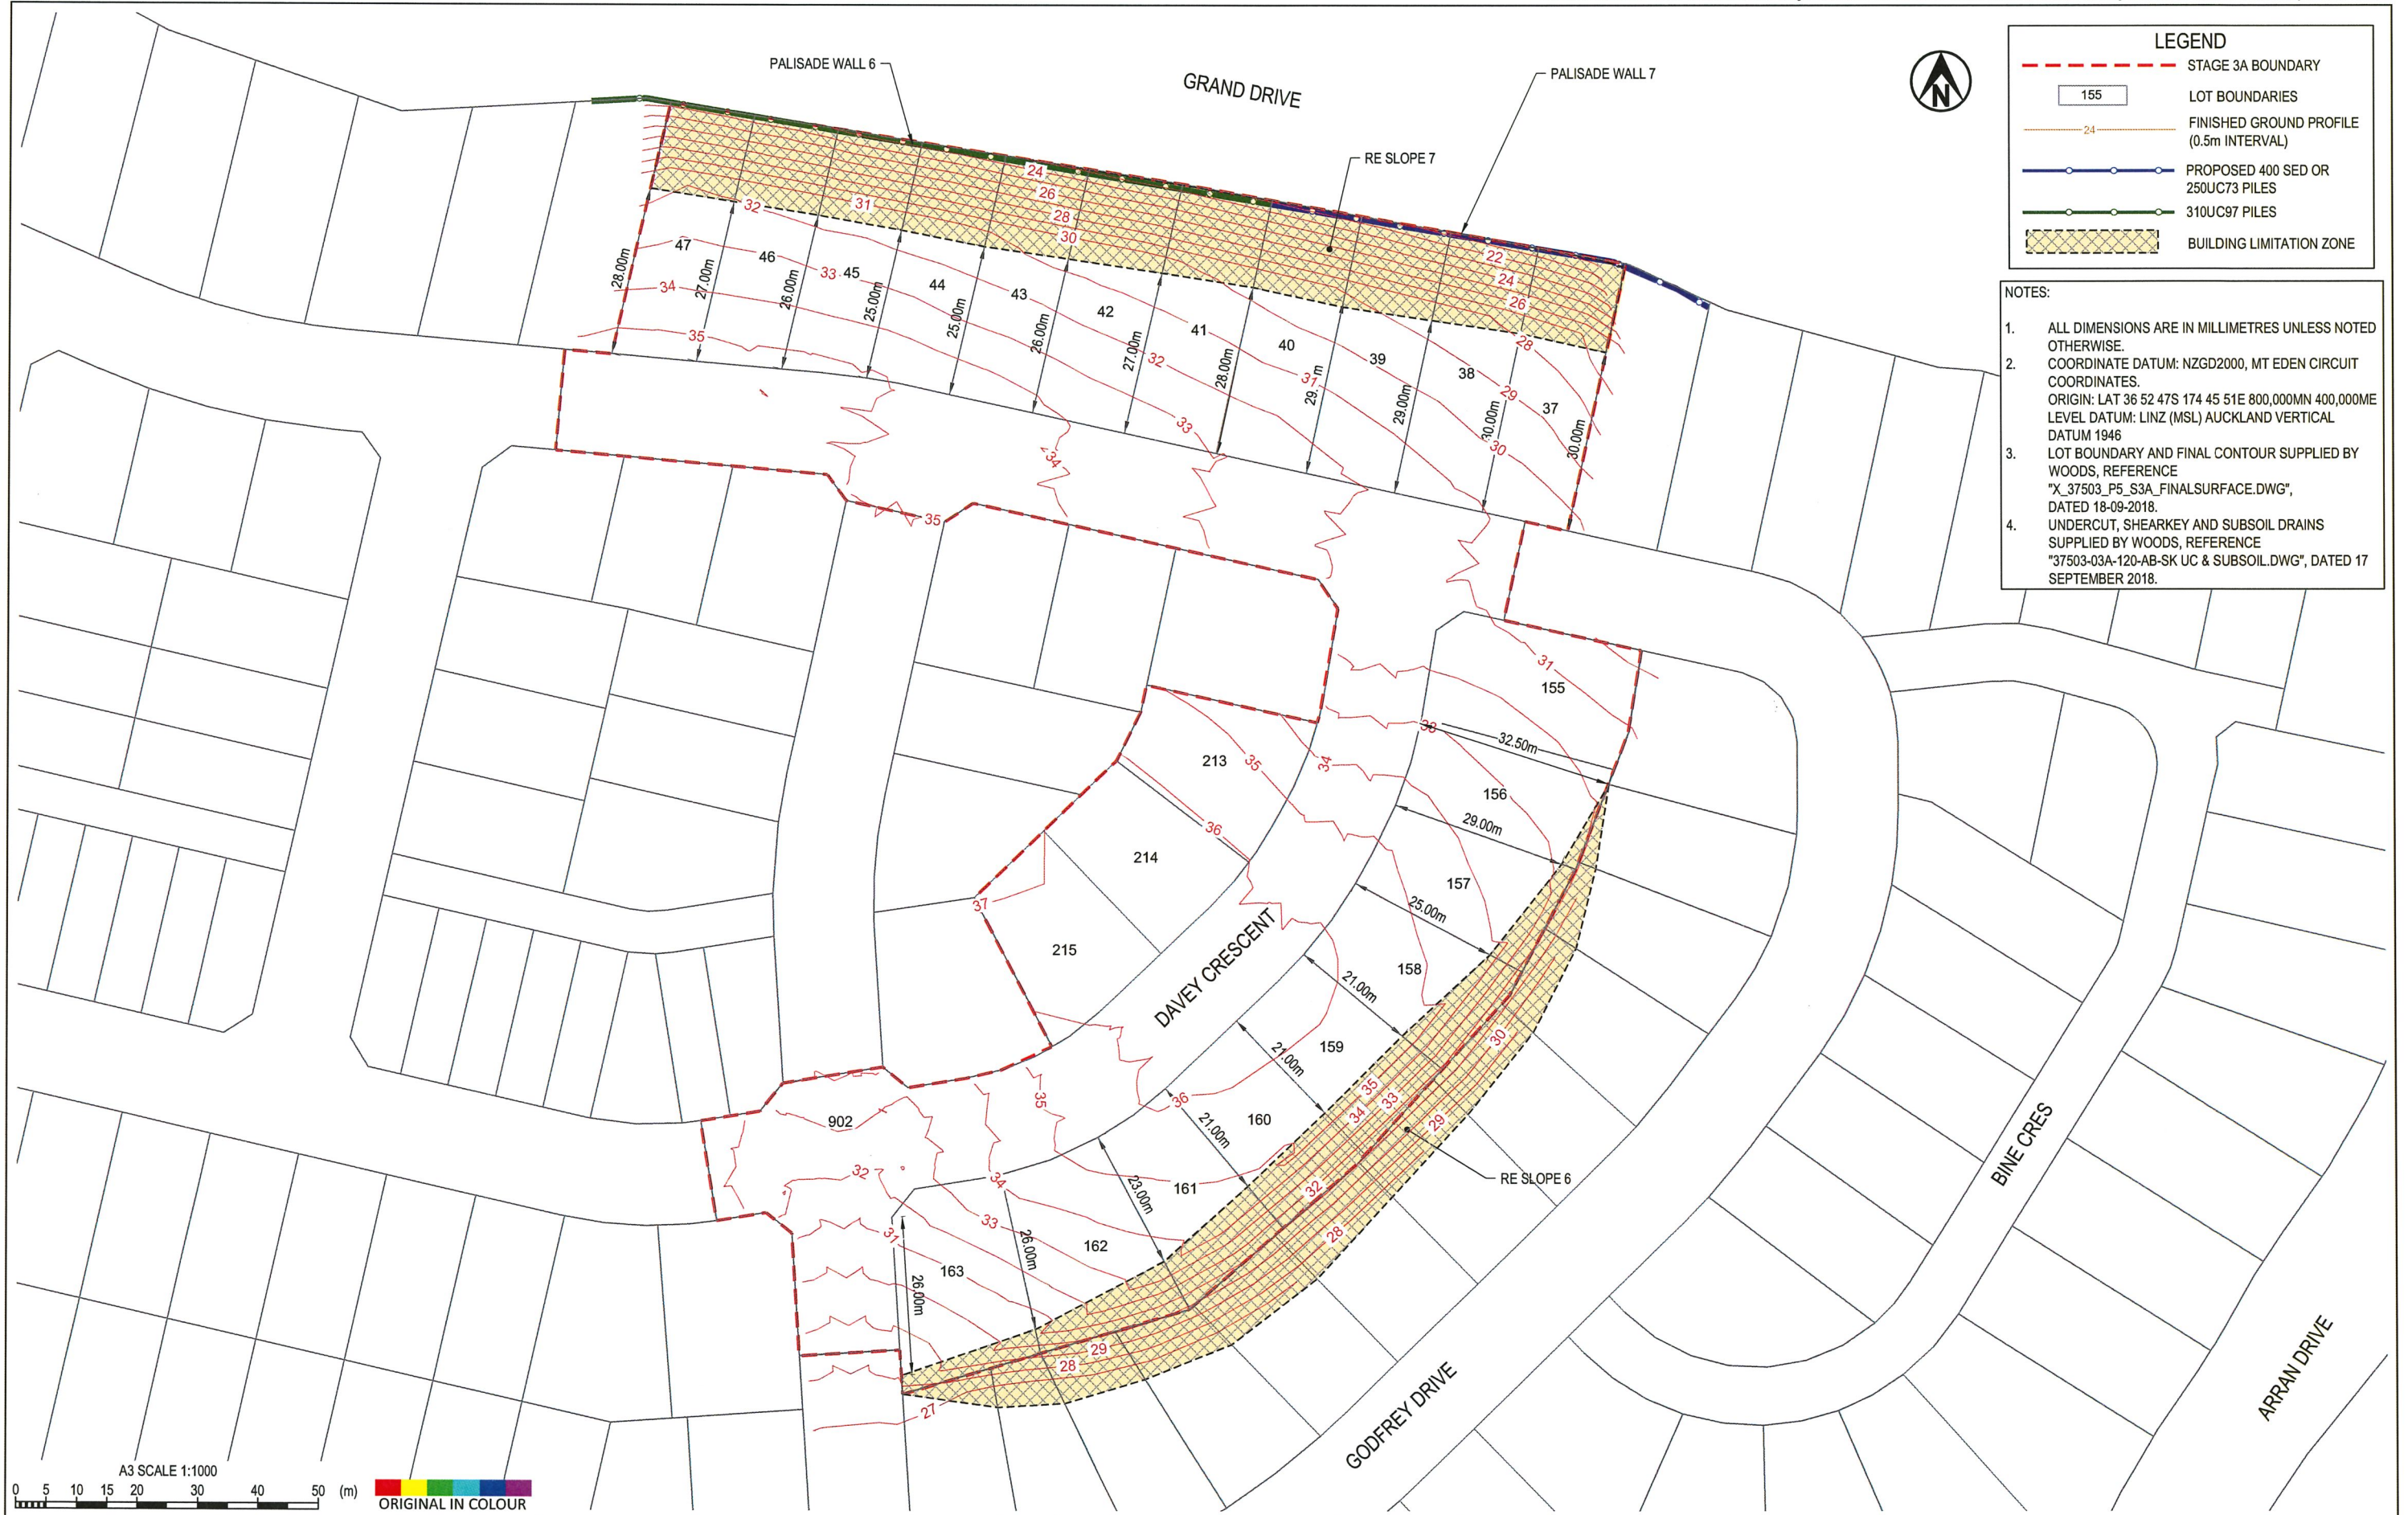
LEGEND

- - - STAGE 3A BOUNDARY
- 155 LOT BOUNDARIES
- FINISHED GROUND PROFILE (0.5m INTERVAL)
- PROPOSED 400 SED OR 250UC73 PILES
- 310UC97 PILES
- BUILDING LIMITATION ZONE

The slope faces will be subject to a planting covenant and building limitation zone preventing construction within this area. Protection of the geogrids from damage also precludes construction across the slope faces and immediately adjacent to the slope crest. Accordingly, a building restriction zone has been applied across the slopes (See Sections 5.3 and 6.6).

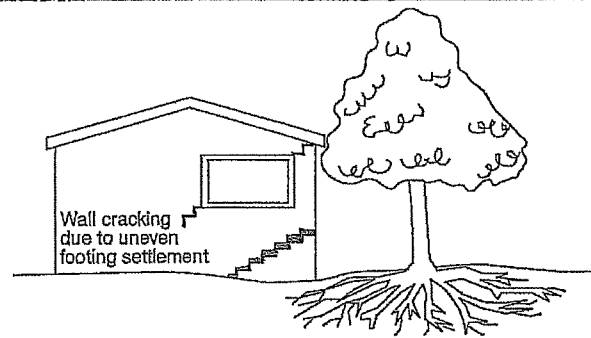
Trees can cause shrinkage and doming

As the moisture absorption process completes its journey to the innermost areas of the building, the internal footings will rise. If the spread of moisture is roughly even, it may be that the symptoms will temporarily disappear, but it is more likely that swelling will be uneven, creating a difference rather than a disappearance in symptoms. In buildings with timber flooring supported by bearers and joists, the isolated piers will rise more easily than the strip footings or piers under walls, creating noticeable doming of flooring.

As the weather pattern changes and the soil begins to dry out, the external footings will be first affected, beginning with the locations where the sun's effect is strongest. This has the effect of lowering the external footings. The doming is accentuated and cracking reduces or disappears where it occurred because of dishing, but other cracks open up. The roof lines may become convex.

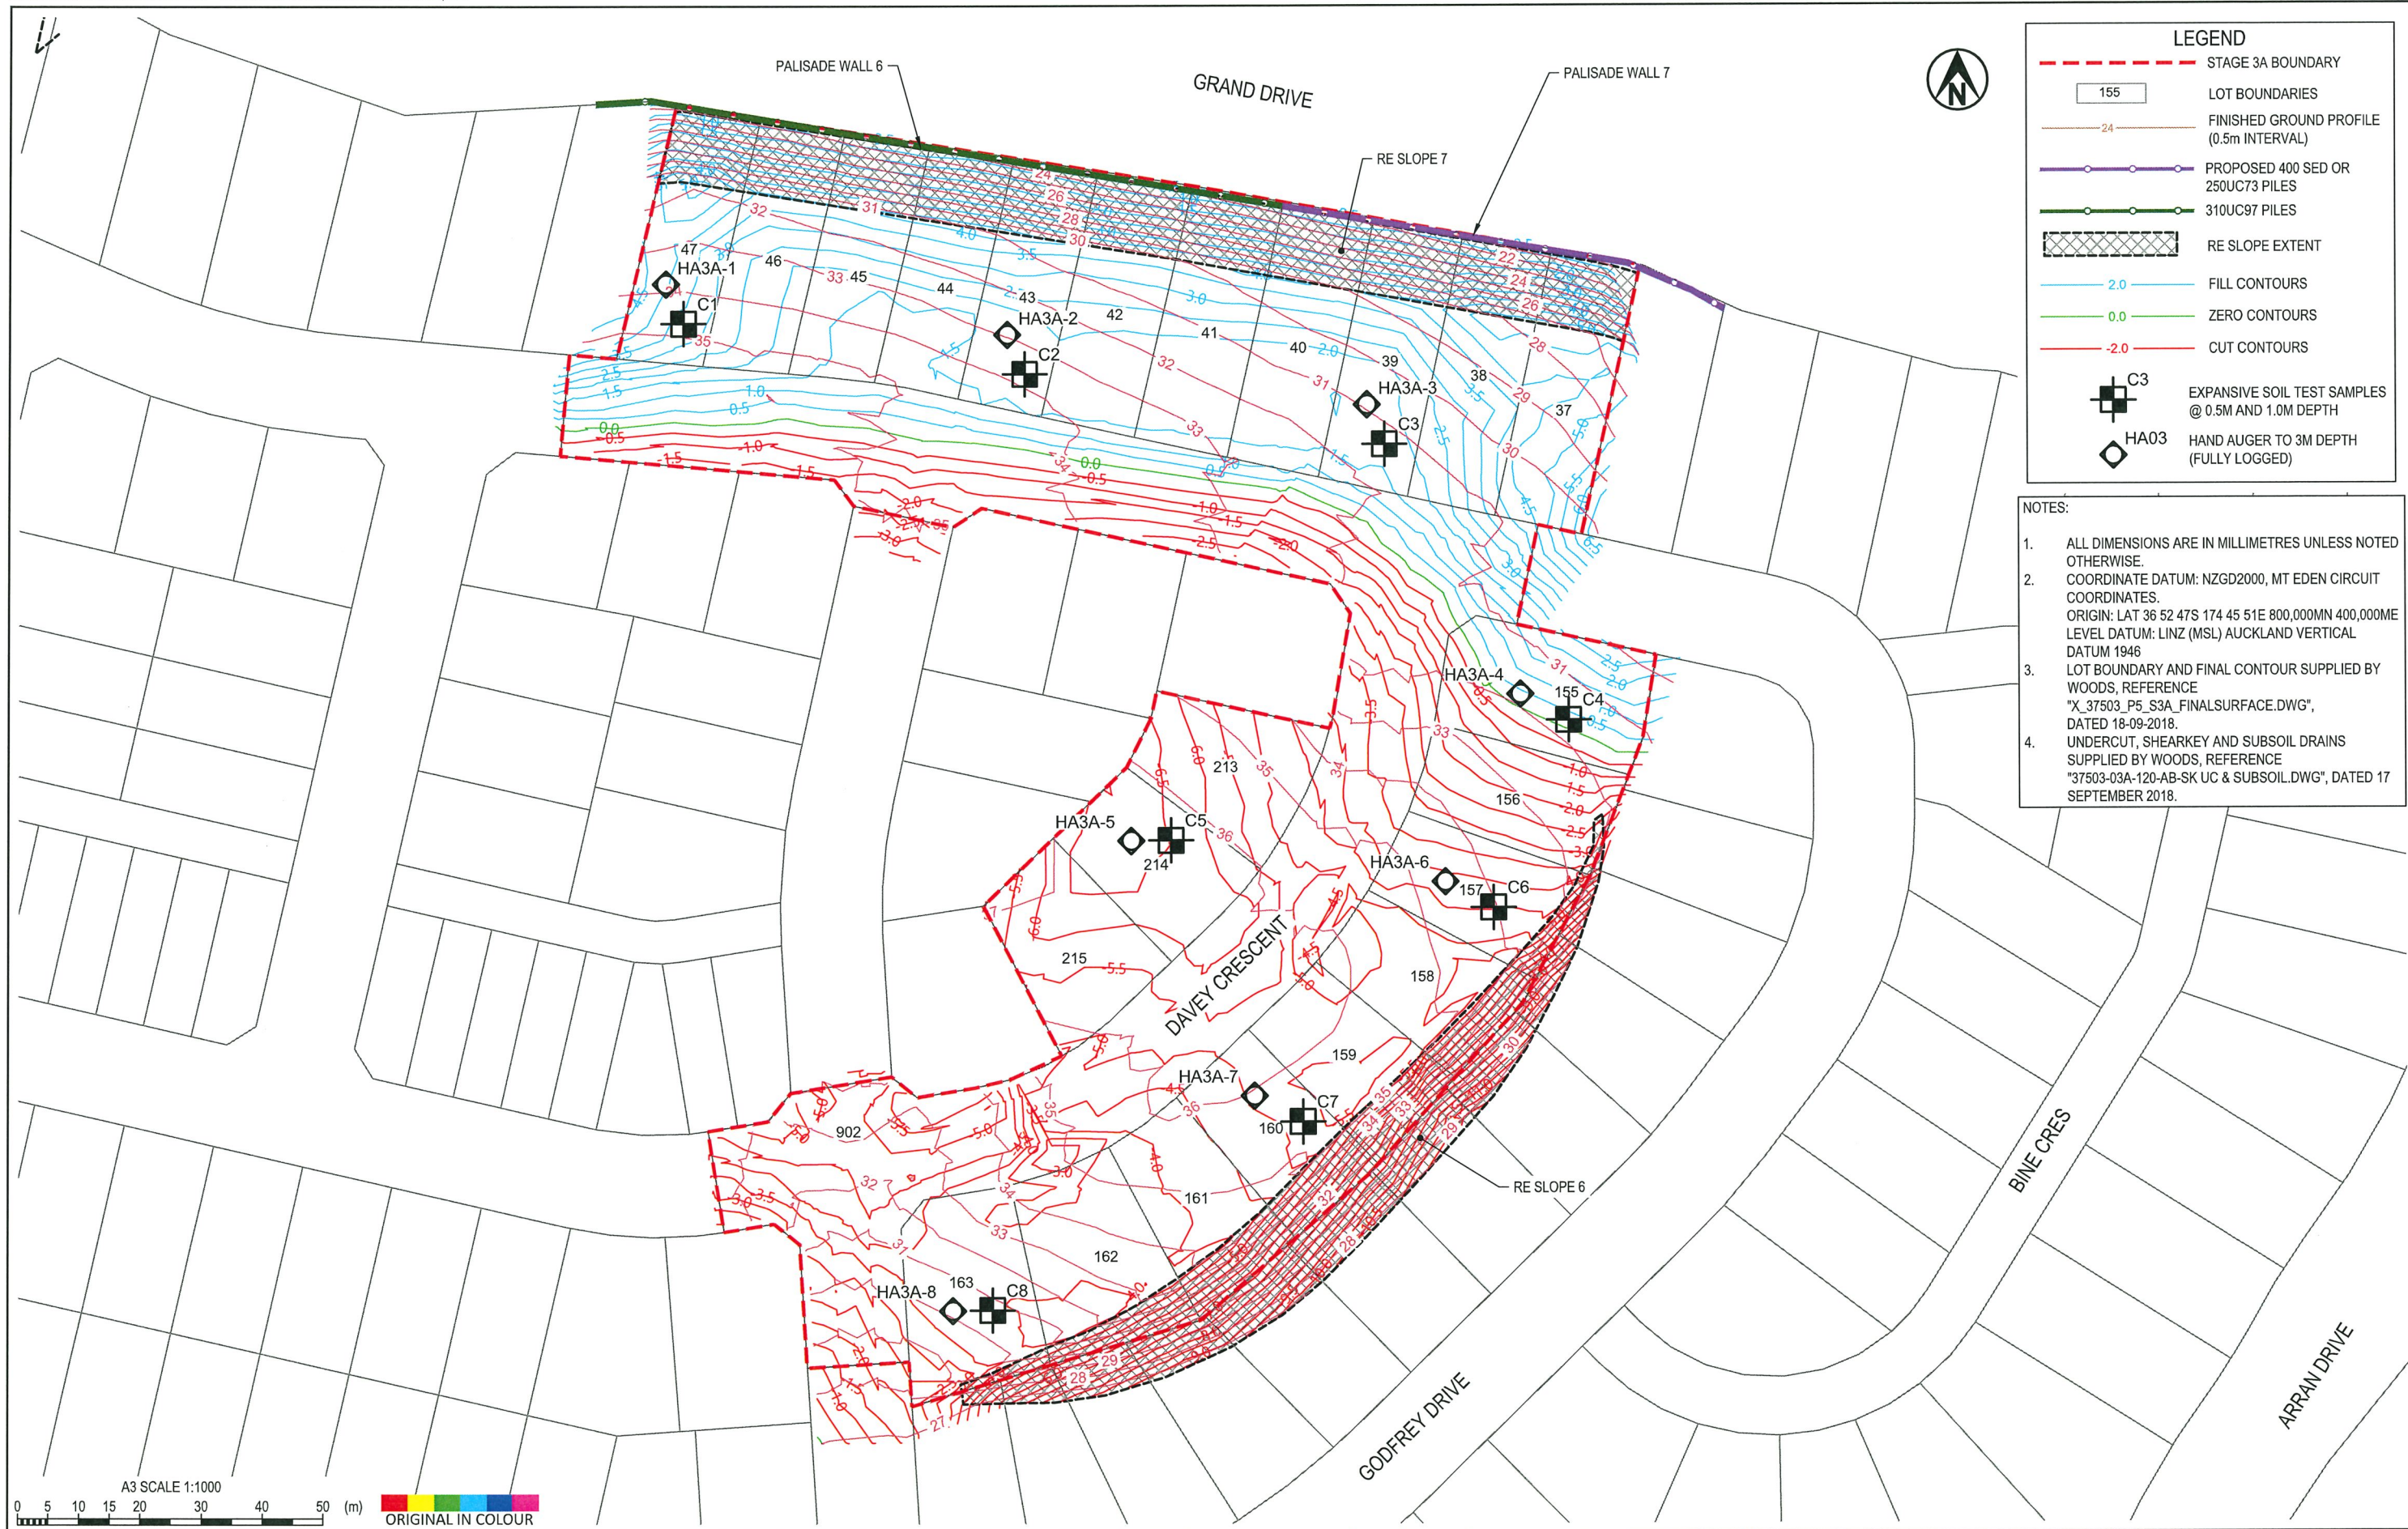
DESIGNED DRAWN DESIGN CHECKED DRAWING CHECKED	JXXL JC	Sep.18 Sep.18	DRAWING STATUS COMPLETION REPORT	CLIENT WFH PROPERTIES LTD
	NOT FOR CONSTRUCTION			PROJECT MILLWATER - ARRANS HILL
THIS DRAWING IS NOT TO BE USED FOR CONSTRUCTION PURPOSES UNLESS SIGNED AS APPROVED				TITLE PRECINCT 5 STAGE 3A POST EARTHWORKS INVESTIGATION PLAN
1	COMPLETION REPORT ISSUE	JC	SCALE (A3) 1:1000	DWG No. 21854.0031-AHP5S3A-121 REV 1
REV	DESCRIPTION	CAD	CHK	DATE
		APPROVED		DATE

- **21854.0031–AHP5S3A–121** **Post Earthworks Investigation Plan**
- **21854.0031–AHP5S3A–122** **Topsoil Depths Plan**
- **21854.0031–AHP5S3A–123** **Earthworks Testing Location Plan**
- **Soil Expansion Test Results**
- **Post Earthworks Investigation Borehole Logs HA3A-1 to HA3A-8**
- **Earthworks Test Results**

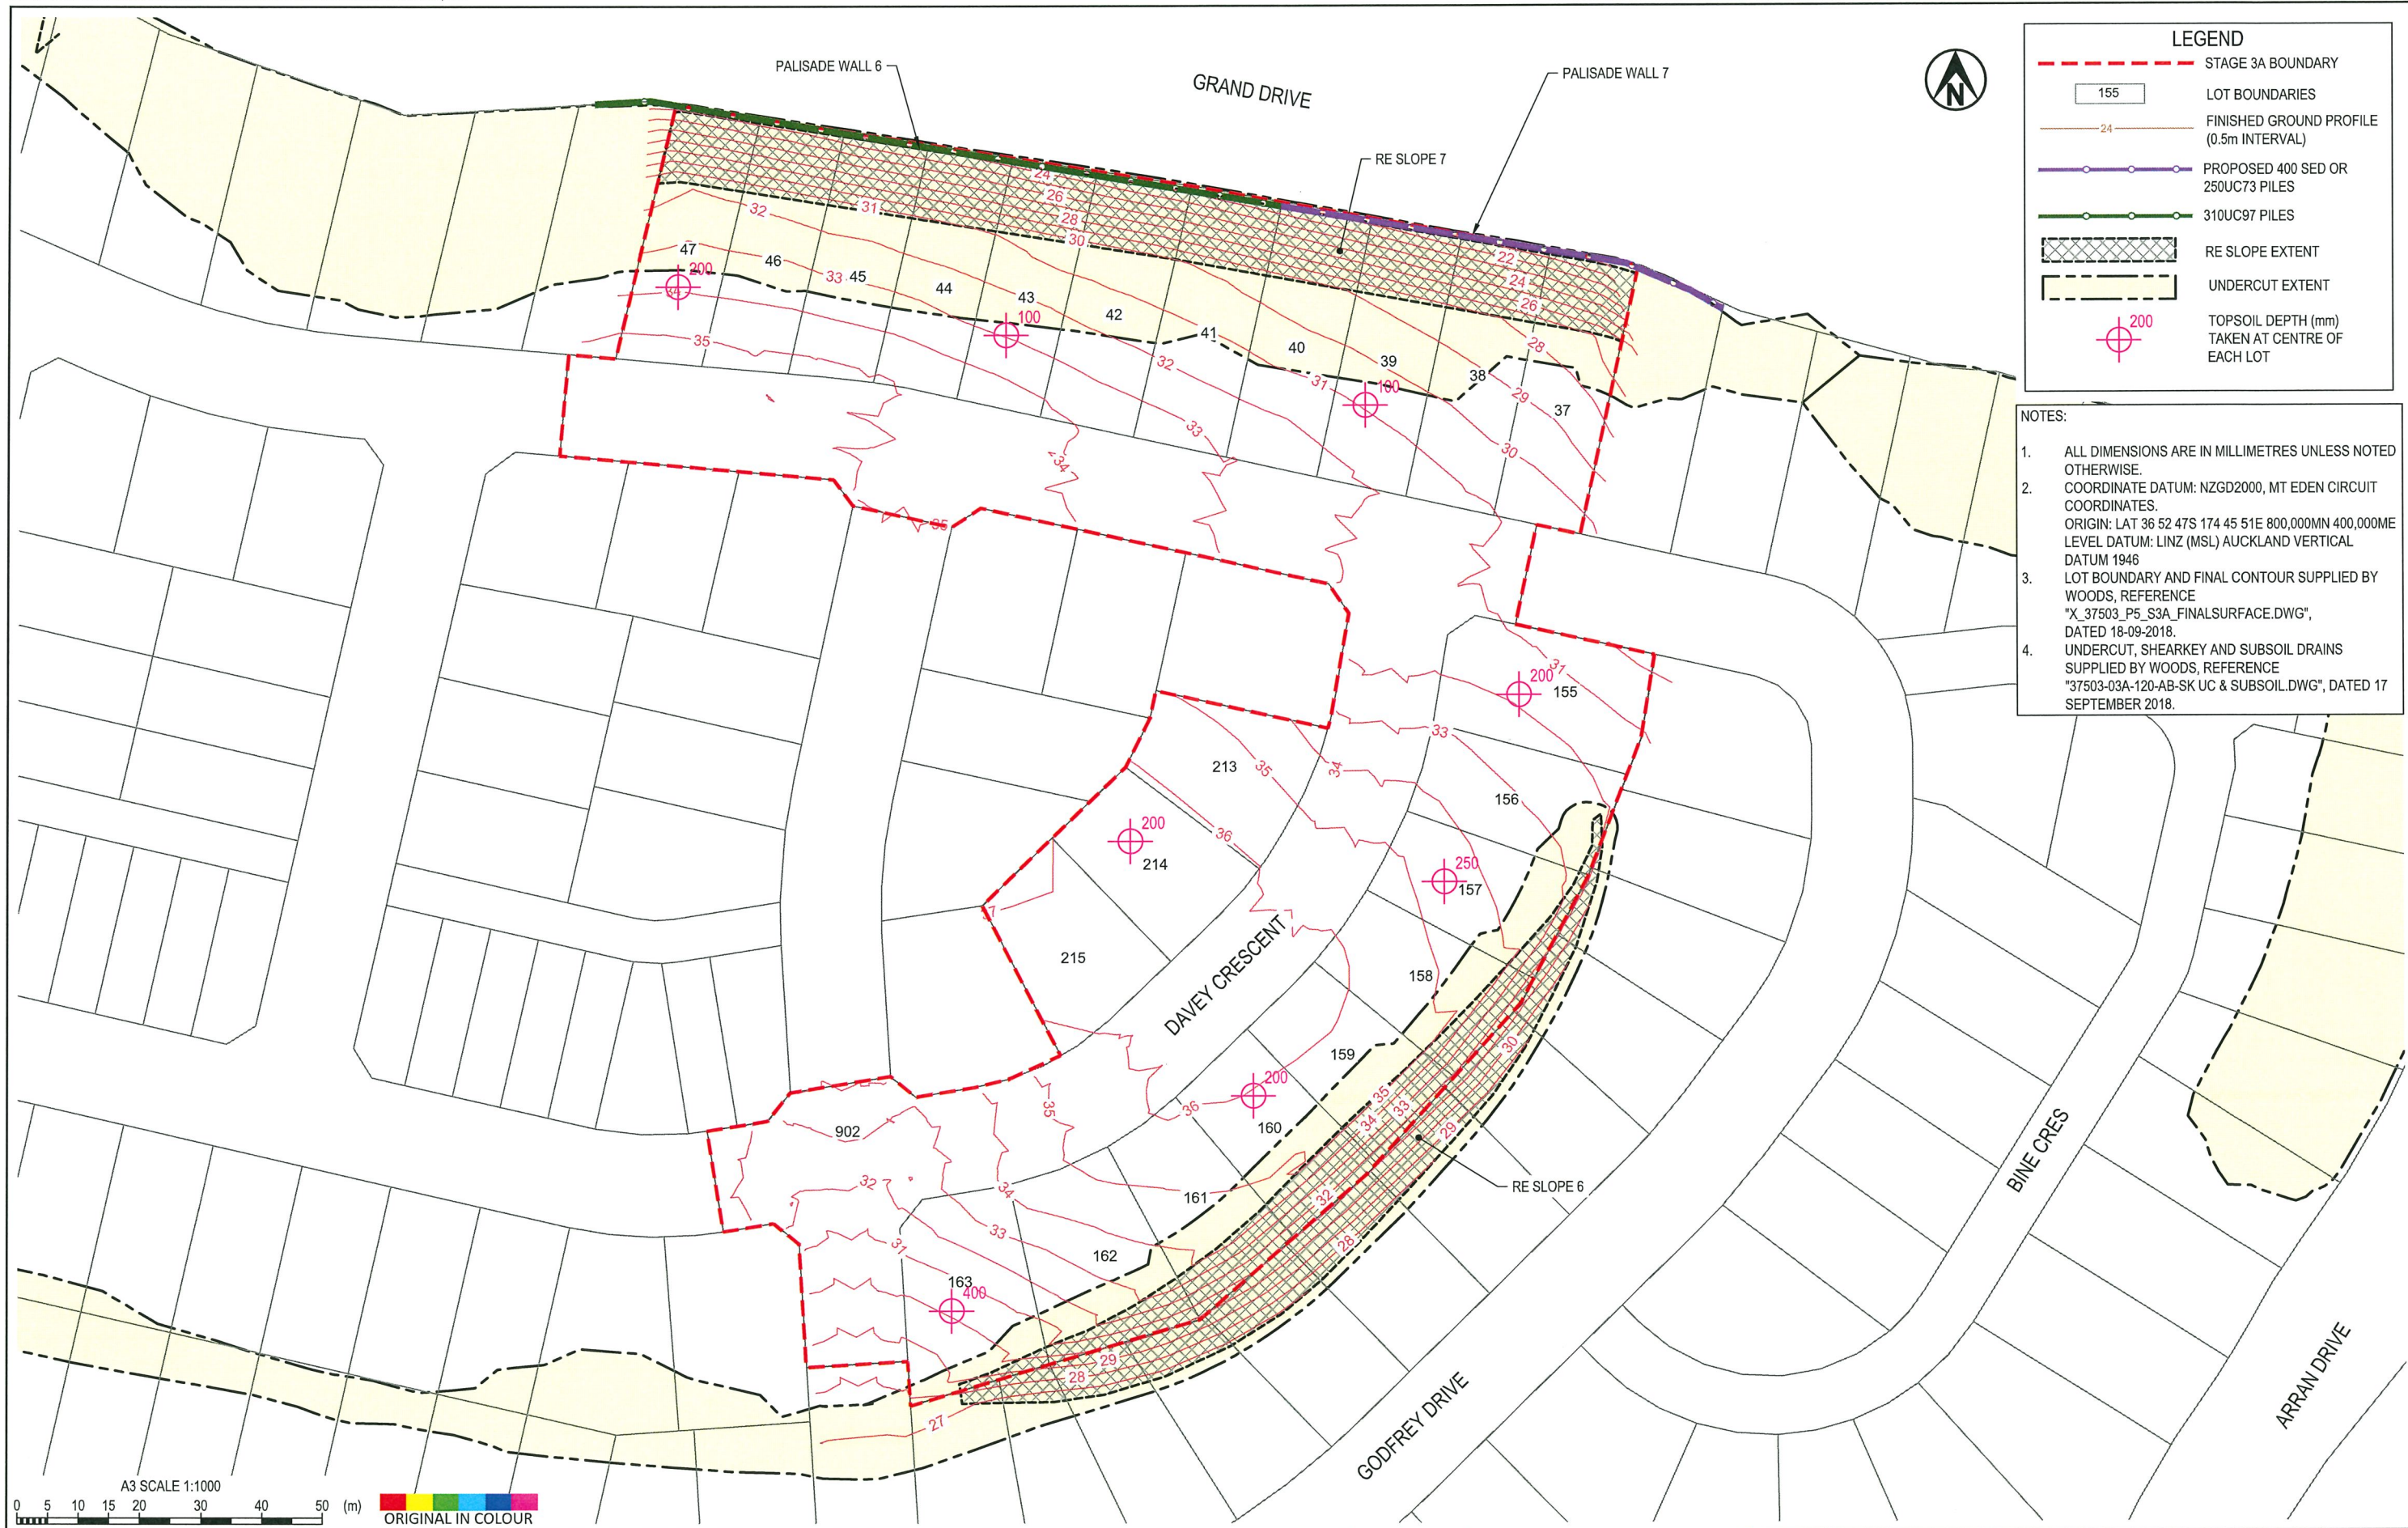
CLIENT	WFH PROPERTIES LTD
PROJECT	MILLWATER - ARRANS HILL
TITLE	PRECINCT 5 STAGE 3A TOPSOIL DEPTHS PLAN
SCALE (A3)	1:1000
DWG No.	21854.0031-AHP5S3A-122
REV	1

DESIGNED	JXXL	Sep.18	DRAWING STATUS	CLIENT	WFH PROPERTIES LTD
DRAWN	JC	Sep.18	COMPLETION REPORT	PROJECT	MILLWATER - ARRANS HILL
DESIGN CHECKED				TITLE	PRECINCT 5 STAGE 3A
DRAWING CHECKED					TOPSOIL DEPTHS PLAN
NOT FOR CONSTRUCTION			THIS DRAWING IS NOT TO BE USED FOR CONSTRUCTION PURPOSES UNLESS SIGNED AS APPROVED		
1	COMPLETION REPORT ISSUE	JC		SCALE (A3)	1:1000
REV	DESCRIPTION	CAD	CHK	DATE	APPROVED
					DATE

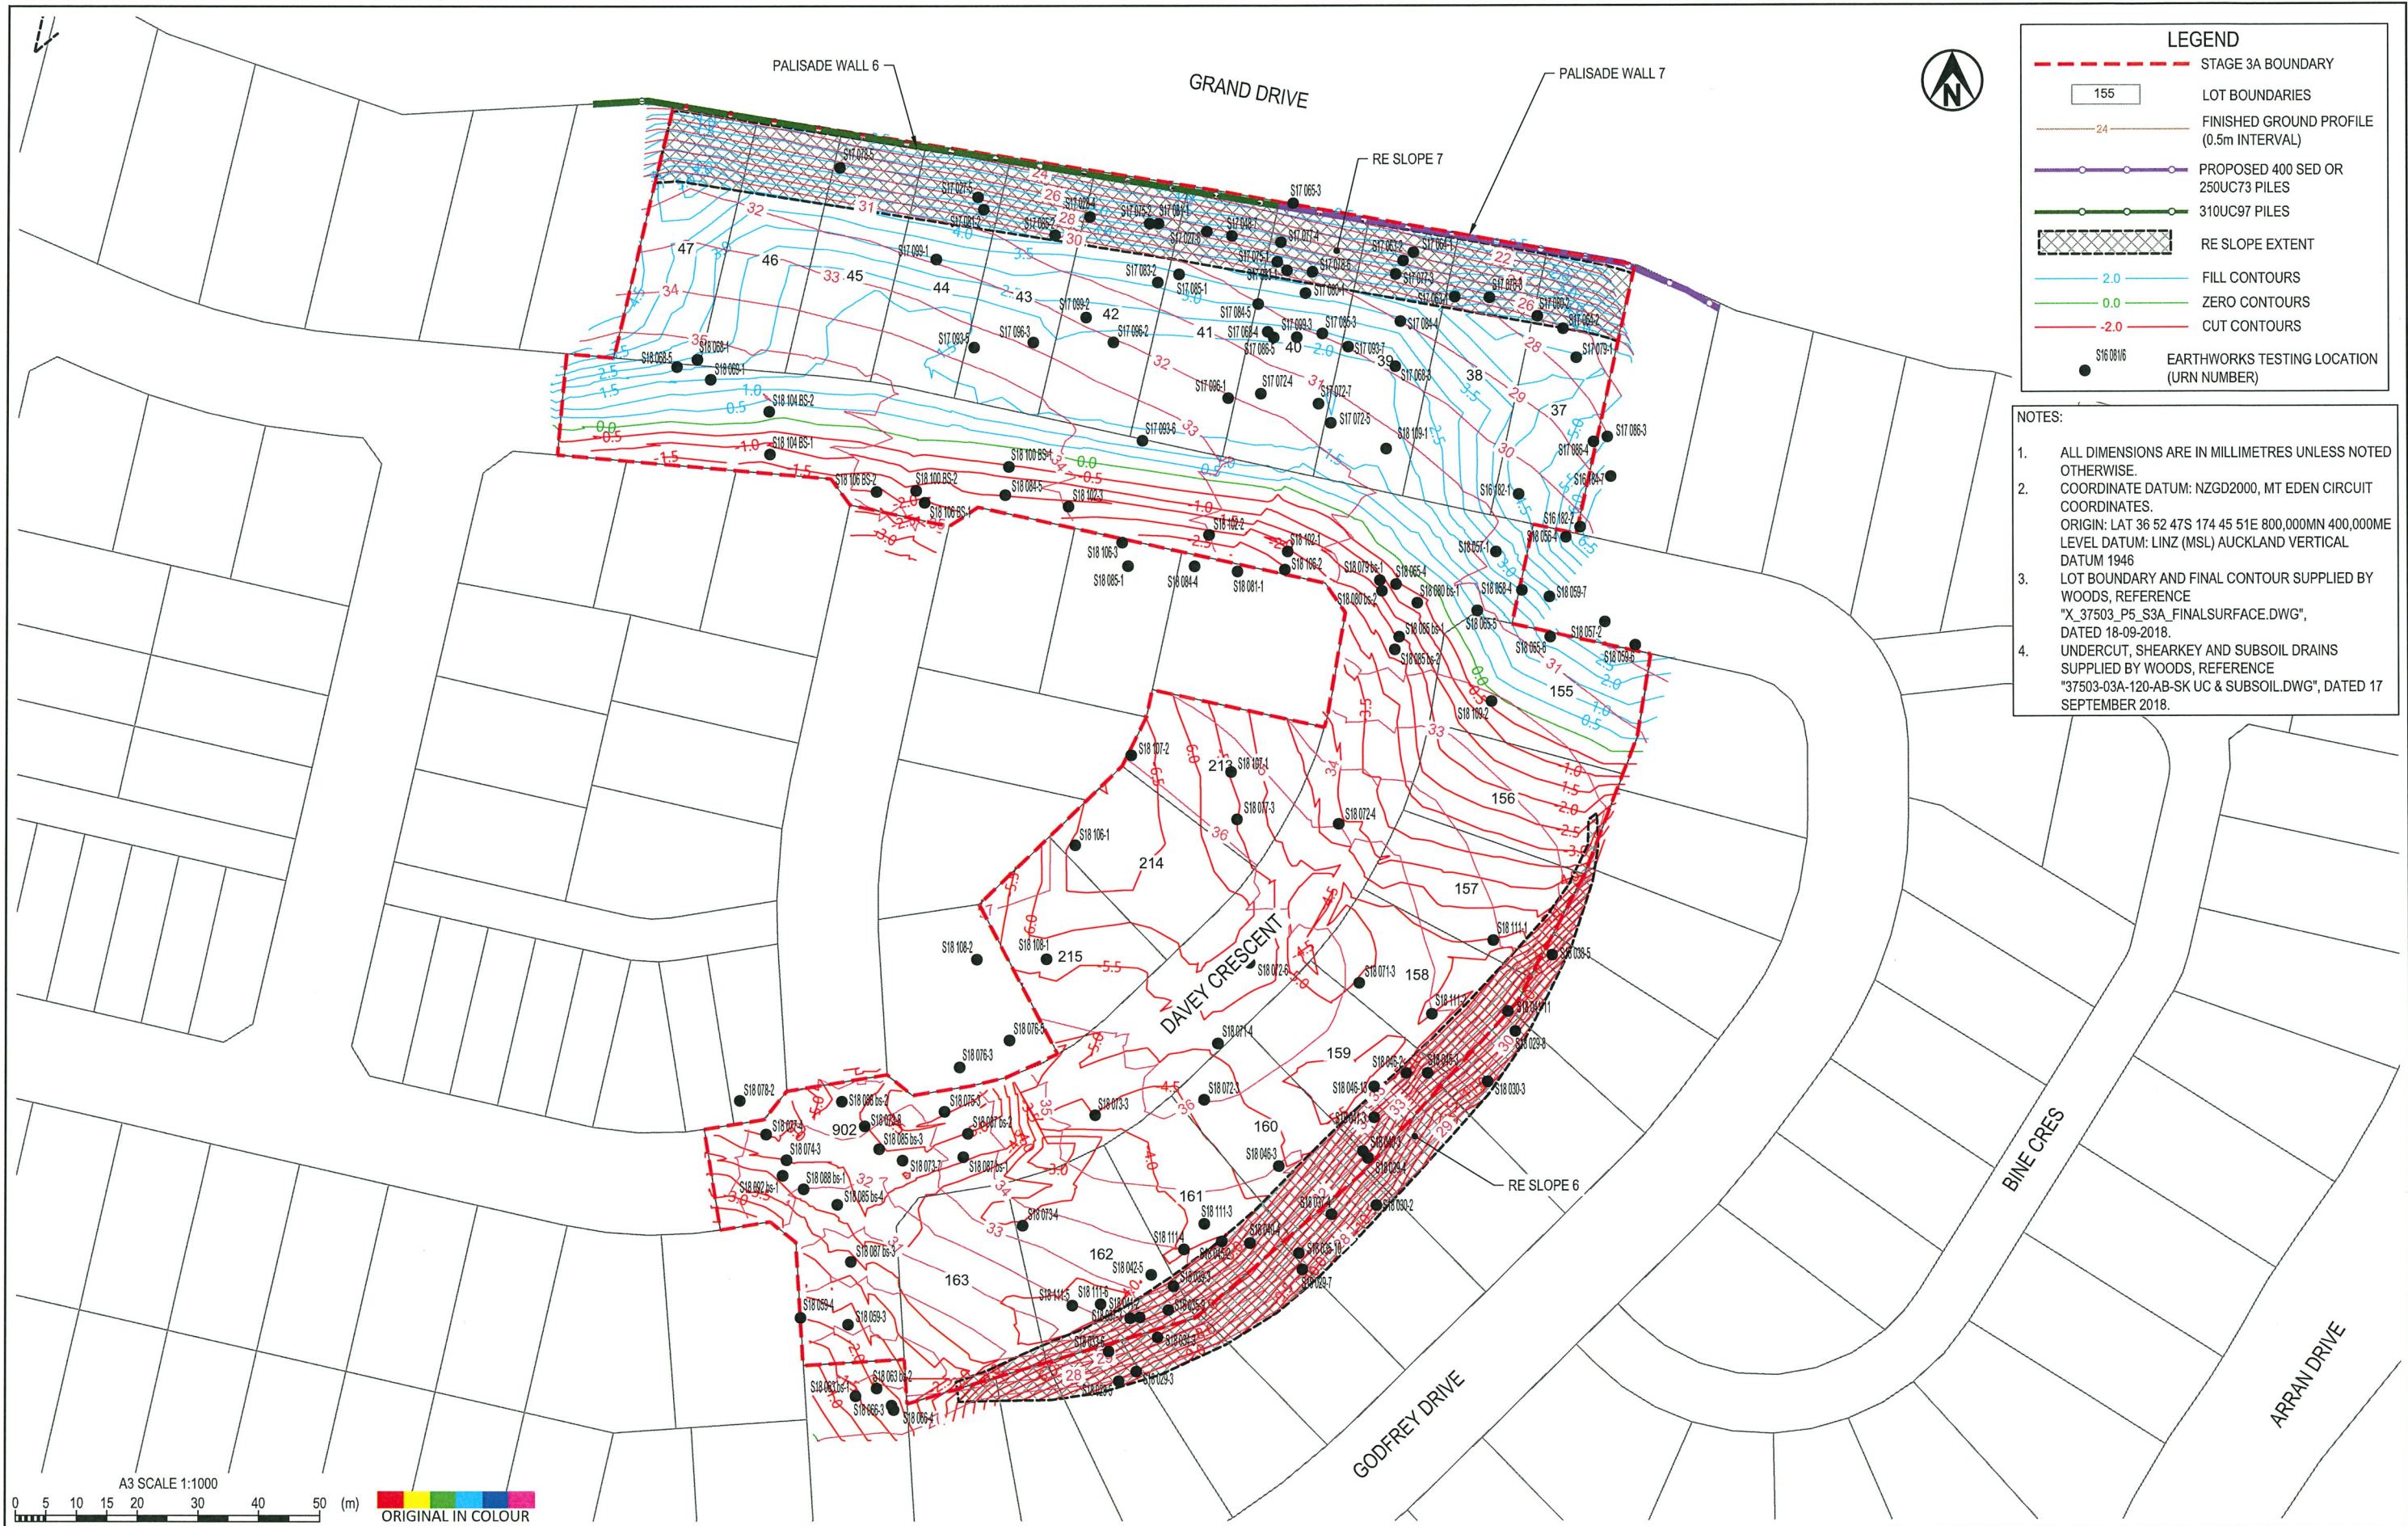
- STAGE 3A BOUNDARY
- LOT BOUNDARIES
- FINISHED GROUND PROFILE (0.5m INTERVAL)
- PROPOSED 400 SED OR 250UC73 PILES
- 310UC97 PILES
- RE SLOPE EXTENT
- FILL CONTOURS
- ZERO CONTOURS
- CUT CONTOURS
- S18 0816 EARTHWORKS TESTING LOCATION (URN NUMBER)
