Tonkin + Taylor

Tonkin + Taylor Ltd (T+T) was engaged by WFH Properties Ltd to monitor and provide earthworks certification for the 45 No. Residential Lots contained within Stage 5 of Arran Point Precinct 7 at the Millwater Subdivision in Silverdale. Stage 5 comprises residential Lots 14 to 43 and 69 to 83, Joint Owned Access Lane (JOAL) Lot 802, and Road 01 (Arran Point Parade) and Road 03 (Cassidy Drive) inclusive as shown on the Woods Final Contours Plan (Woods Ref 37005–05–100–AB) in Appendix A1.

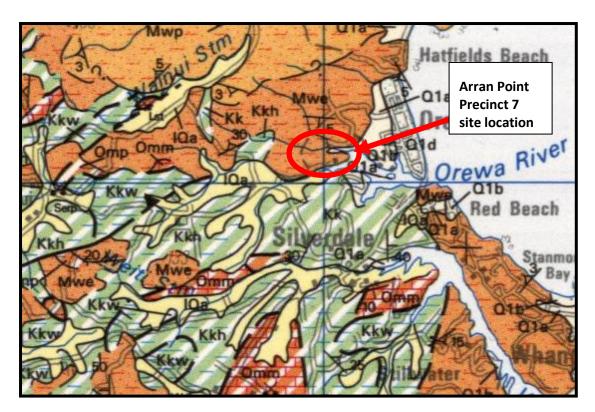
Figure 1 - Local Geology (from Edbrooke)

Published geological mapping and information indicates the Arran Point Precinct 7 area is underlain by East Coast Bays Formation (ECBF) materials. In addition to the ECBF materials, our investigations identified the presence of alluvial materials in isolated locations on site.

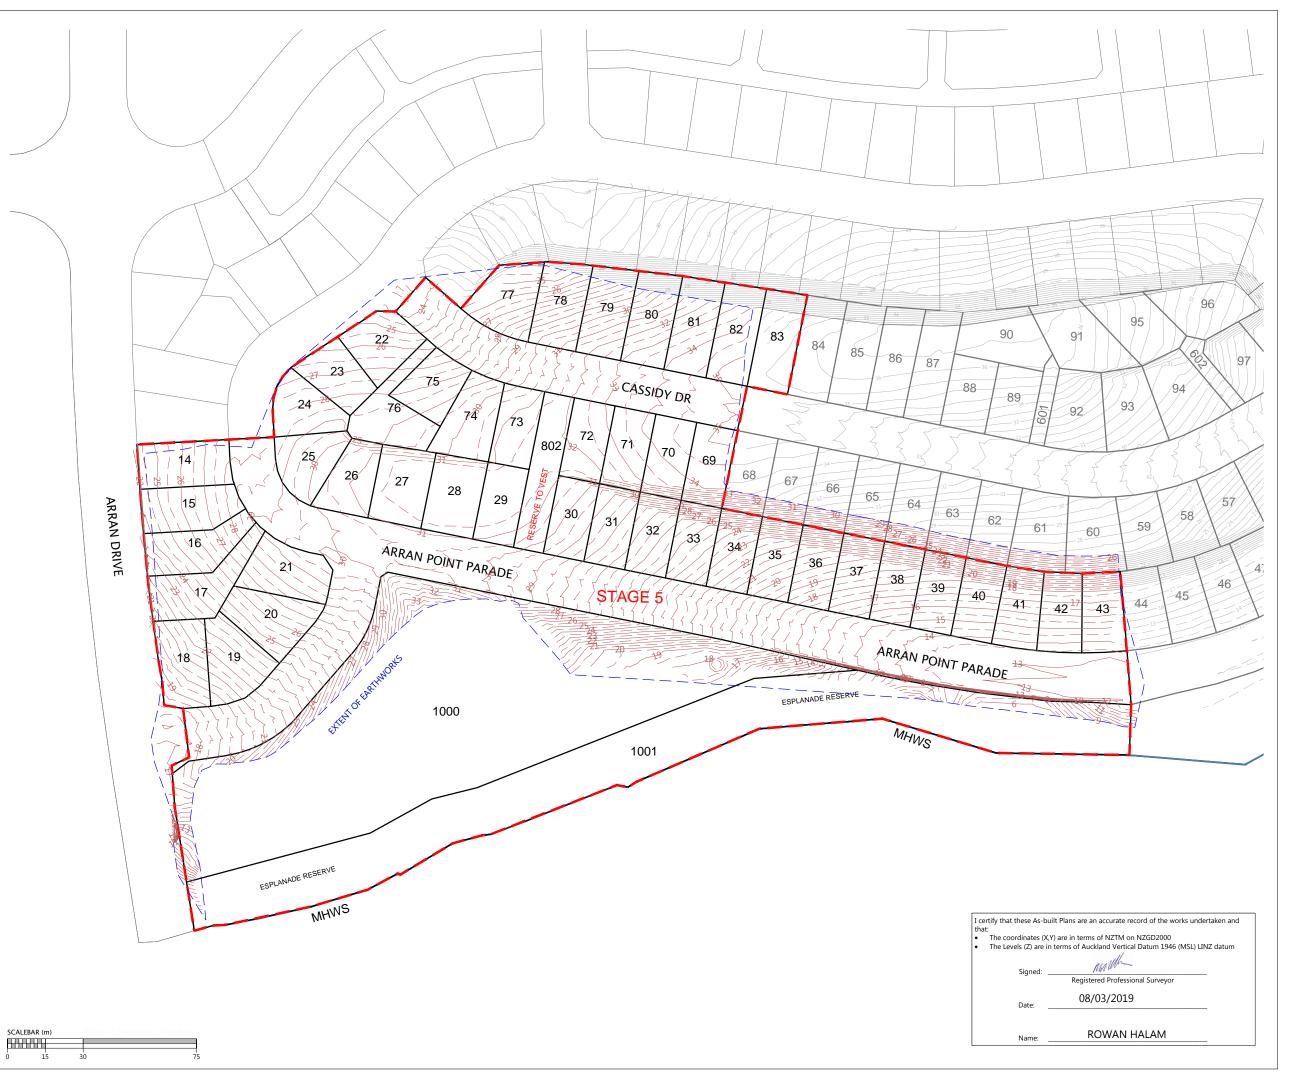
FINAL CONTOURS PLAN

1. CONTOURS ARE AT 0.5 METRE INTERVALS

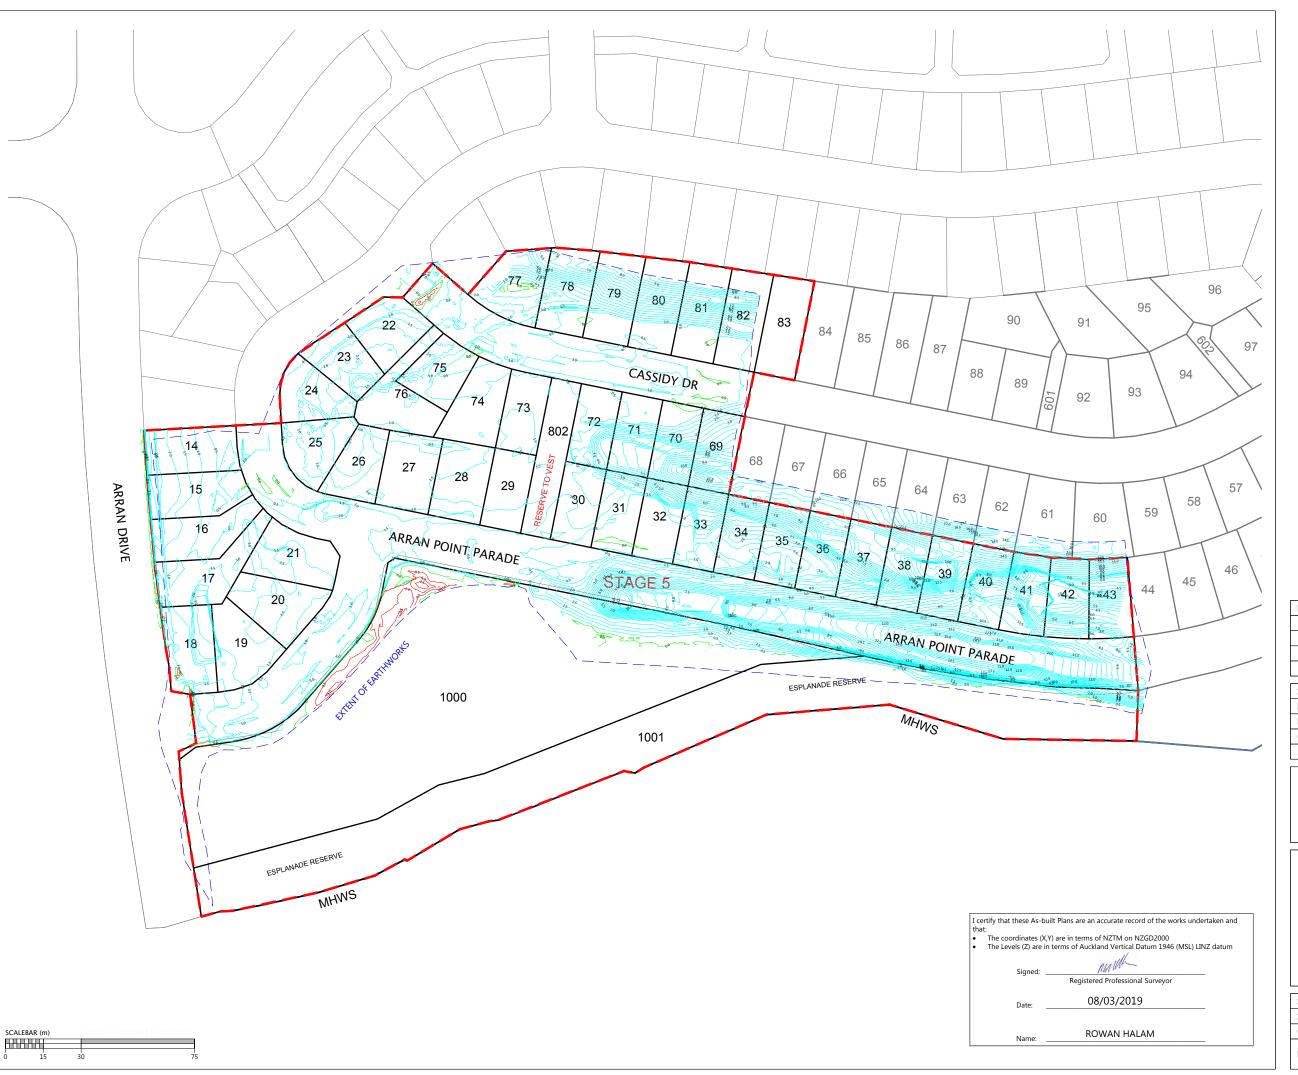
CUT & FILL AS-BUILT LOWEST TO FINAL SURFACE SHEET 1 OF 3

1. CONTOURS ARE AT 0.5 METRE INTERVALS

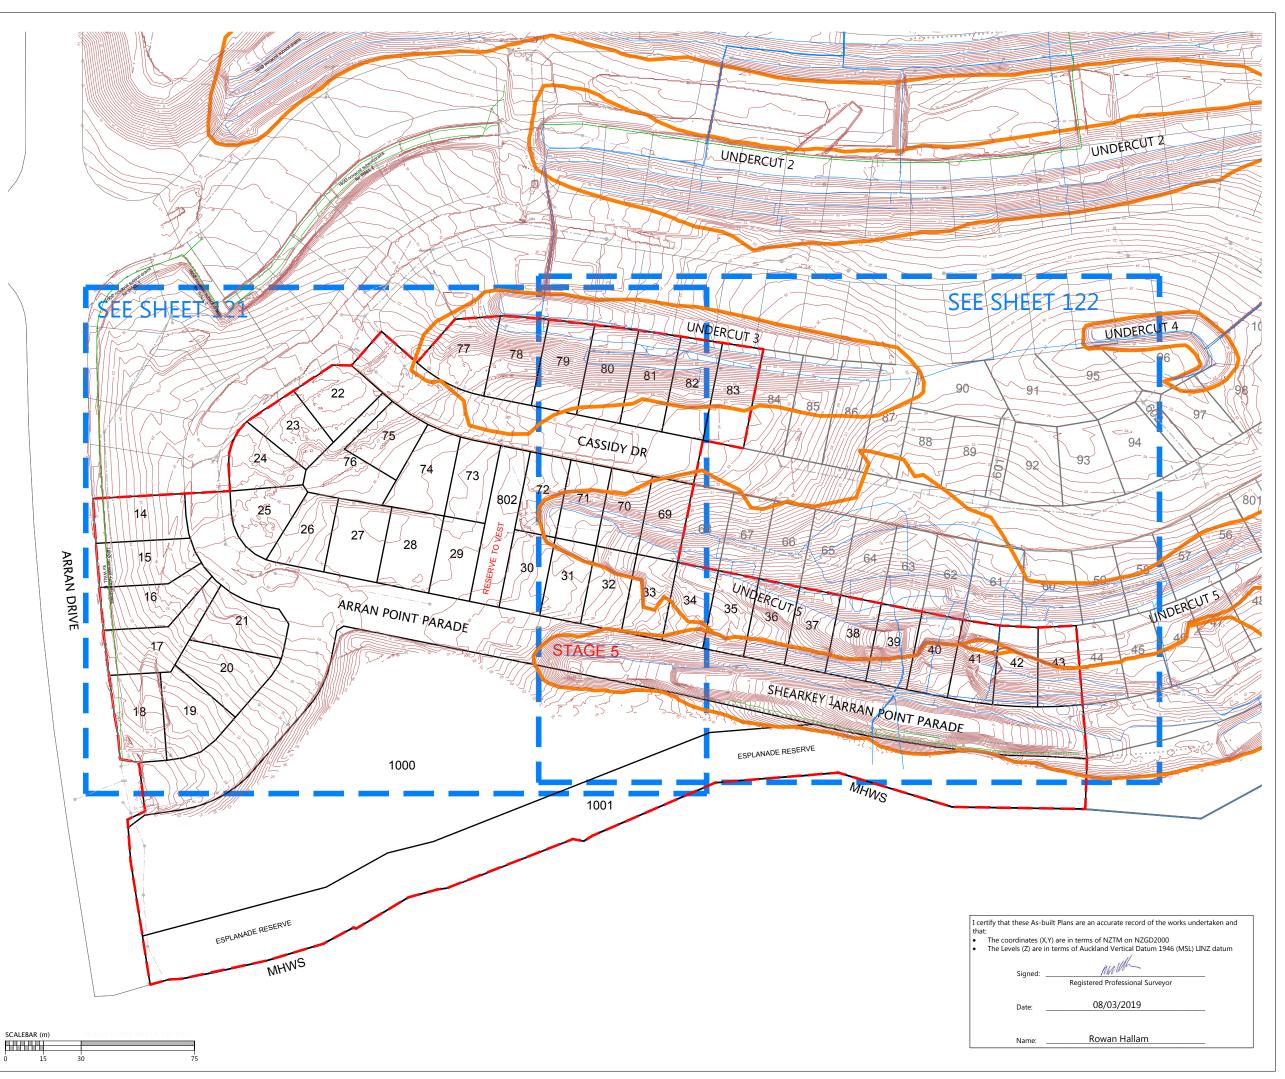
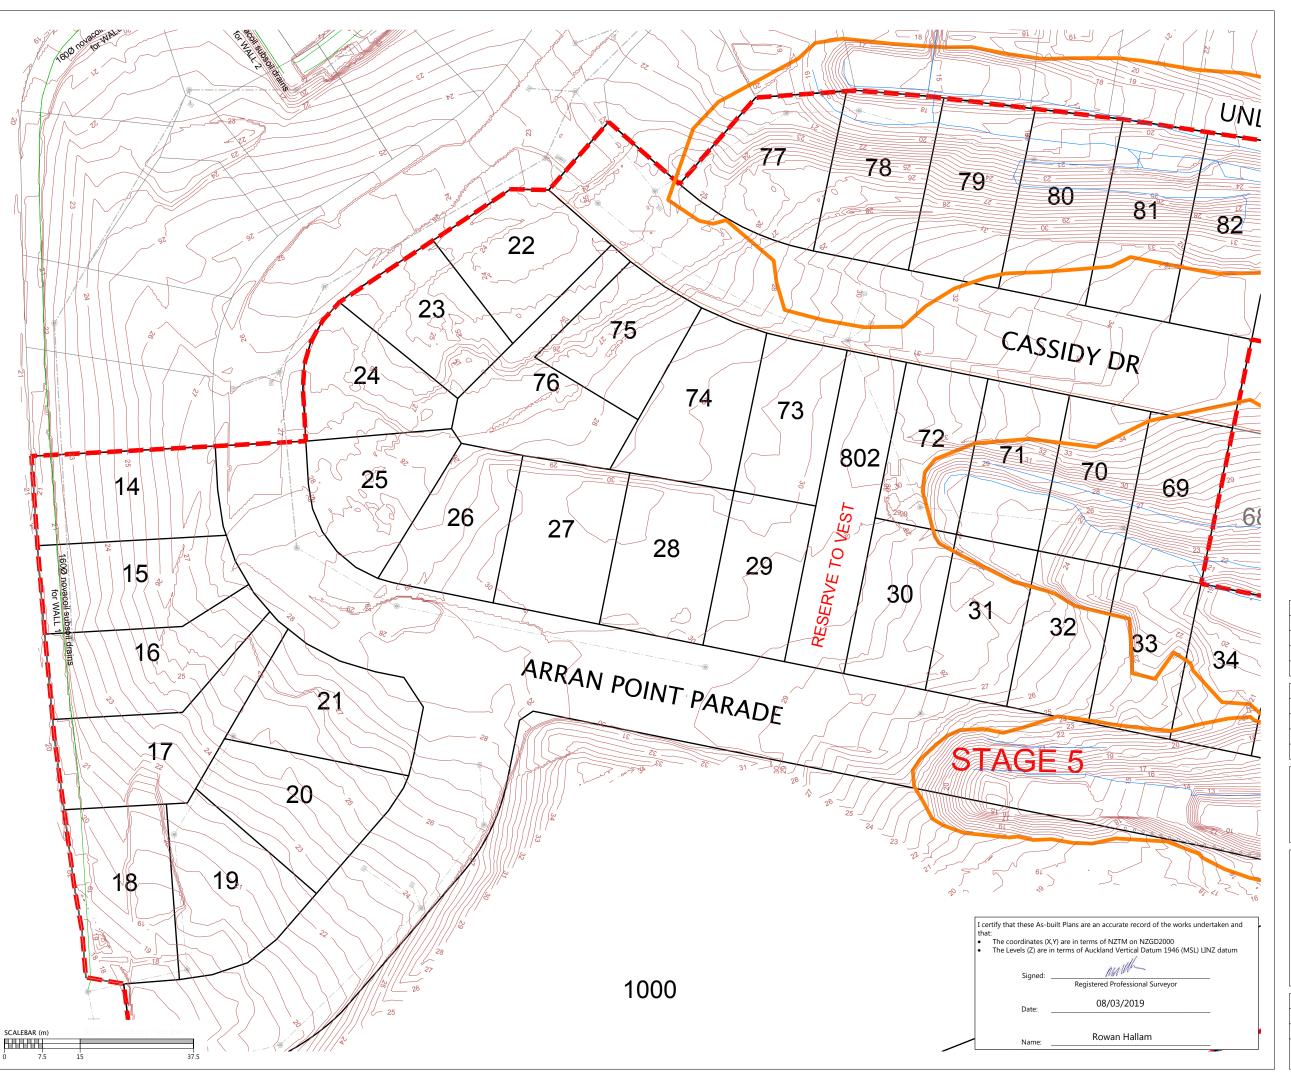
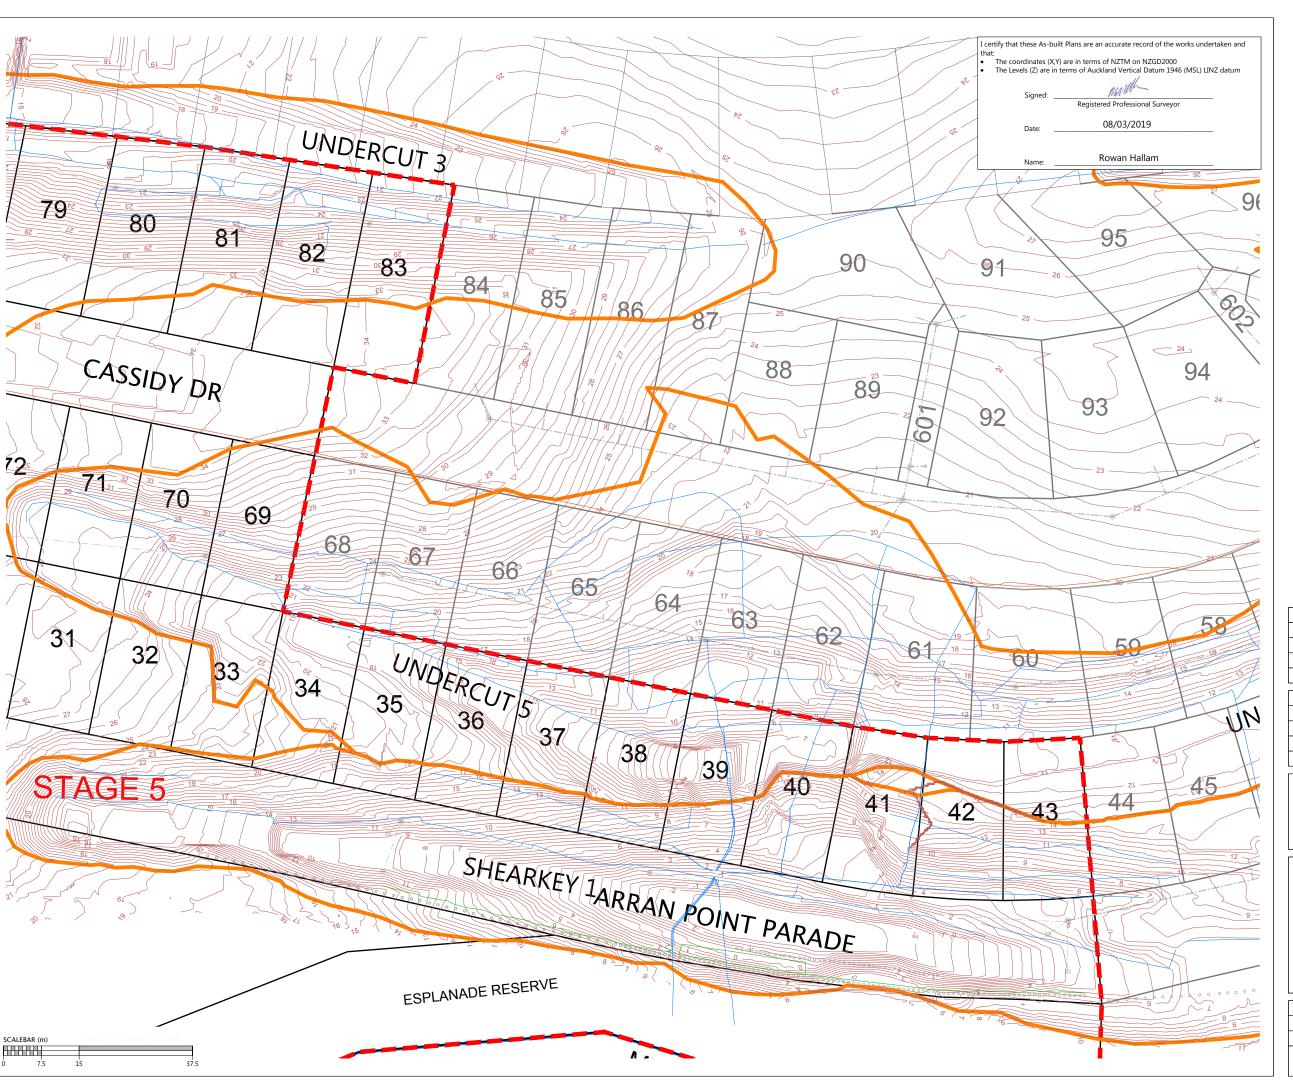
SHEAR KEY, UNDERCUT AND SUBSOIL DRAIN ASBUILT SHEET 2 OF 3

- 1. CONTOURS ARE AT 0.5 METRE INTERVALS
- 2. SUBSOIL DATA SUPPLIED BY CONTRACTOR

As noted in Section 3.1, a drainage blanket was installed at the rear of the reinforced block of soil which comprises a minimum of 300mm thickness of SAP50 scoria, covered in Bidim A19 geotextile filtercloth. A 160mm diameter perforated Nexus pipe along the backface of the wall and base of the rear of the reinforced soil block provides a discharge outlet for any groundwater captured in the drainage blanket. The drainage pipes from behind the walls are connected into the reticulated stormwater system (Wall 01) or discharge into the adjacent stream below (Wall 05), as shown on the Woods As–Built plans 37005–05–120–AB to –122–AB in Appendix A1.
